APPRAISAL REPORT

Driver name:	HM Tongeren
Make:	VOLVO
Model / version:	XC40
Vin:	YV1XZBWVFN2768585
Plate:	2BUS842
Mileage:	211486
SOH:	
First registration:	30/03/2022
Color:	Pebble Grey

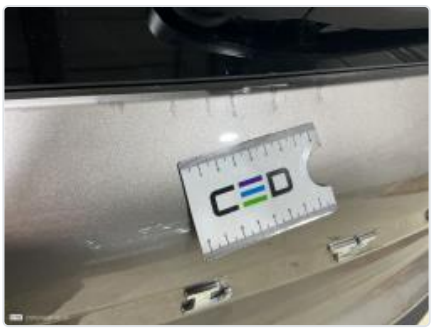
5 - Inner door sill RL - Dent(s) and scratch(es)

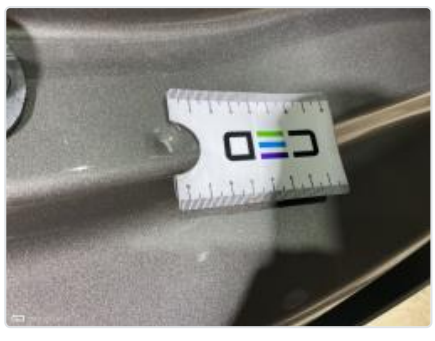
6 - Wing RL - Dent(s) and scratch(es)
