ARVAL
BNP PARIBAS GROUP

2CLX250

INSPECTION REPORT

End of contract

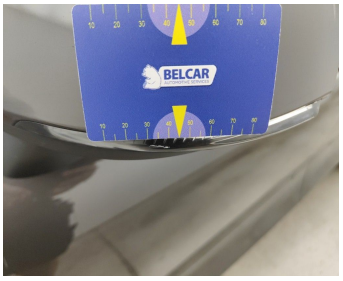
Rear Bonnet / Rear Window / Replace-scratch

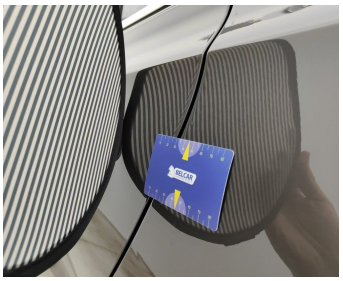
Rear Bonnet // Smart Repair Small-dent
