Expertise

Protocol number: 47971638
Order No. / Reference: 27097819
Inspection date: 7 Oct 2026

Manufacturer: Skoda	Model: Octavia Combi 1.5 TSI Style
VIN: TMBJR0NX9RY032296

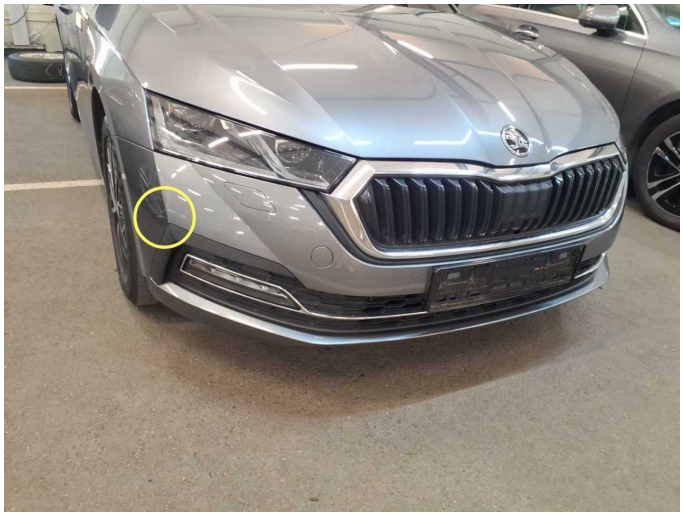
No.	Component group	Description
1	Front bumper	Front bumper - Scratch(es) - Paint
2	Side panel - rear left side	Side panel - Scratch(es) - Paint

Damage 1: Front bumper: Front bumper - Scratch(es) - Paint
