Expertise

Protocol number: 48256501
Order No. / Reference: 27140164
Inspection date: 22 Oct 2026

Manufacturer: Ford	Model: S-Max 2.0 EcoBlue Aut. ST-LINE
VIN: WF0JXXWPCJNM11883

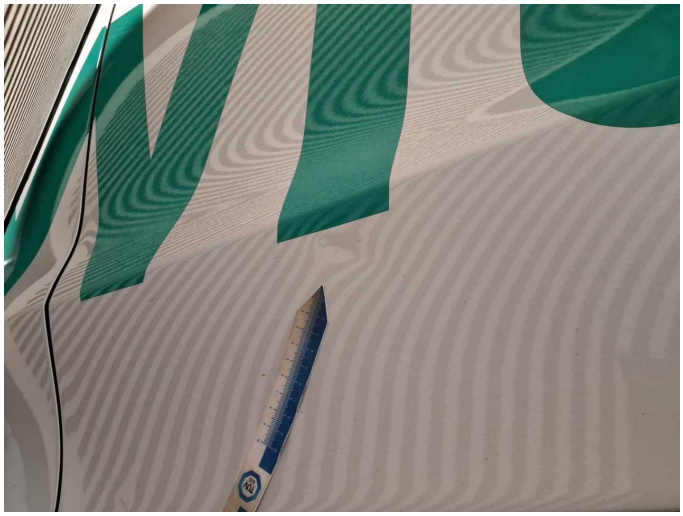
Damage 2: Door - rear left side: Door handle - outside - Scratch(es) - Smart repair

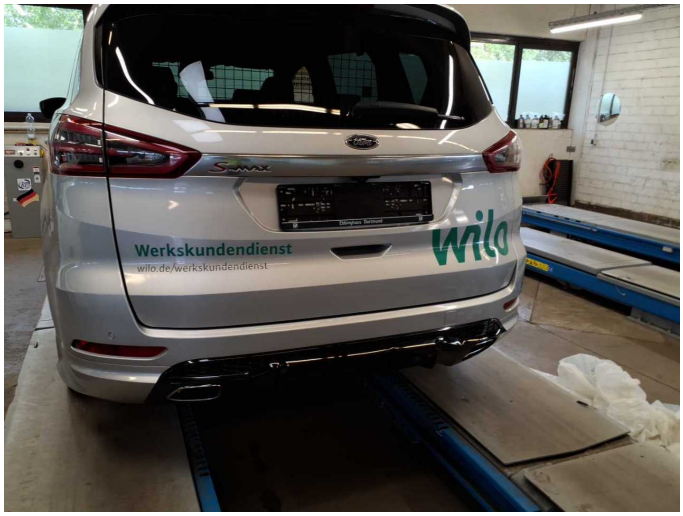
Damage 4: Rear bumper: Rear bumper - Scratch(es) - Smart repair

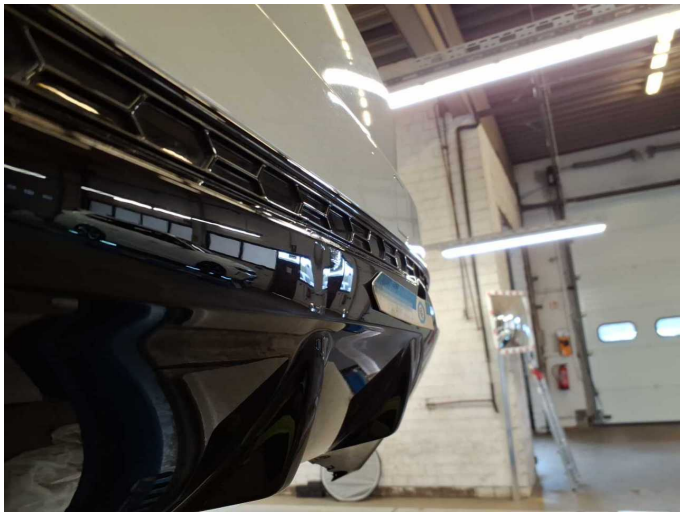
Damage 9: Rear bumper: Spoiler - Deformed - Replace
