Expertise

Protocol number: 48019653
Order No. / Reference: 27104215
Inspection date: 9 Oct 2026

Manufacturer: Volkswagen	Model: ID.4 Pro Performance
VIN: WVGZZZE2ZPE063734

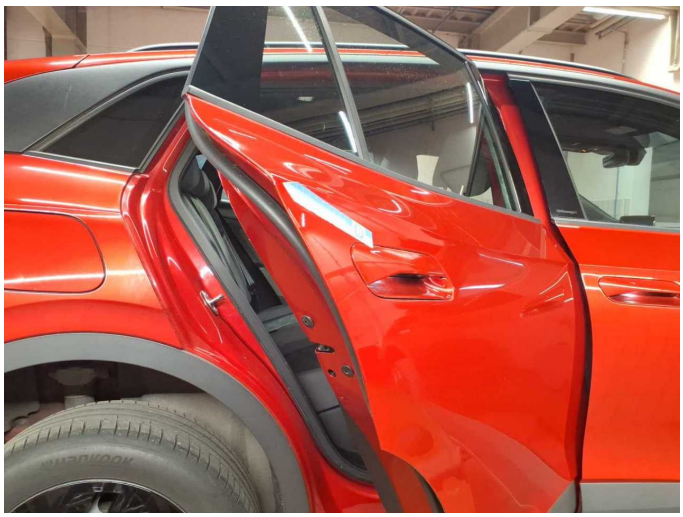
Damage 2: Side panel - rear right side: Sill - Scratch(es) - Smart repair
