TÜV SÜD Auto Partner GmbH
Wiesenring 2
04159 Leipzig

Expertise

Protocol number: 48059457
Order No. / Reference: 27006160
Inspection date: 7 Oct 2026

Manufacturer: Volvo	Model: XC90 T8 AWD Recharge Ultimate Bright
VIN: YV1LFH5V3P1981180

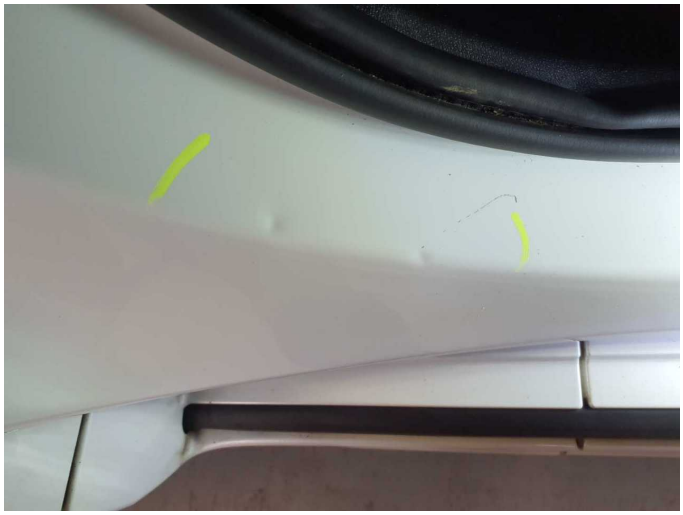
No.	Component group	Description
1	Side panel - rear left side	Wheel arch - Scratch(es) - Smart repair
2	Side panel - rear right side	Sill - Deformed - Smart repair
3	2nd wheel set	1 alloy rim - Scratch(es) - Loss in value
4	Misc.	Inspection / maintenance - Due - Perform
5	Rear bumper	Rear bumper - Scratch(es) - Paint
6	2nd wheel set	1 alloy rim (Materialabtrag) - Damaged - Replace
7	Front bumper	Front bumper - Scratched - Paint

Damage 2: Side panel - rear right side: Sill - Deformed - Smart repair
