Expertise

Protocol number: 48089544
Order No. / Reference: 27085220
Inspection date: 12 Oct 2026

Manufacturer: Audi	Model: A4 Avant 40 TDI quattro S tronic S line
VIN: WAUZZZF48PA063571

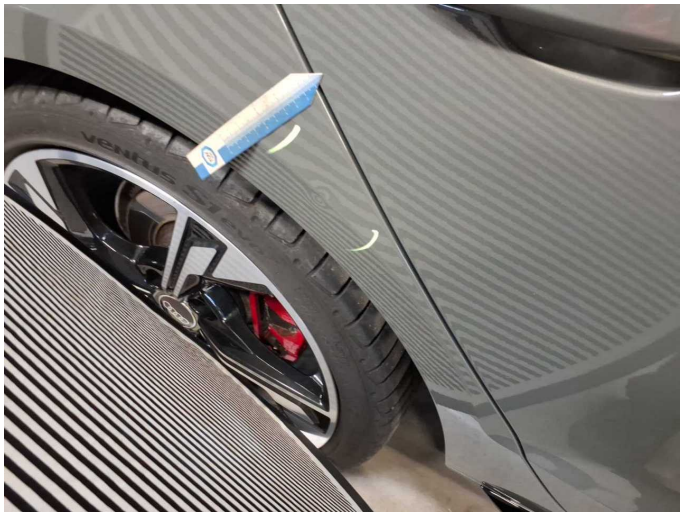
No.	Component group	Description
1	Door - rear left side	Door - dent(s) - Smooth repair work
2	Side panel - rear right side	Side panel - dent(s) - Smooth repair work
3	Bonnet	Bonnet (Sandstrahleffekt) - Stone chips - Paint

Damage 1: Door - rear left side: Door - dent(s) - Smooth repair work

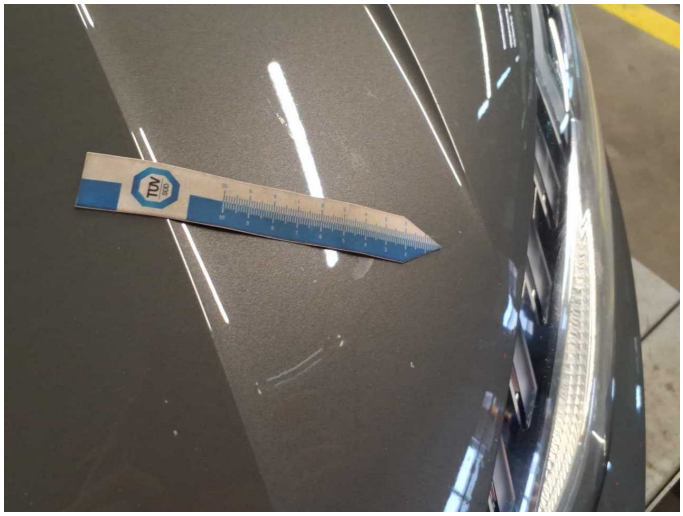
Damage 3: Bonnet: Bonnet (Sandstrahleffekt) - Stone chips - Paint
