Expertise

Protocol number: 48442999
Order No. / Reference: 27138416
Inspection date: 2 Nov 2026

Manufacturer: Audi	Model: A5 Sportback 45 TFSI quattro S tronic advanced
VIN: WAUZZZF53PA001357

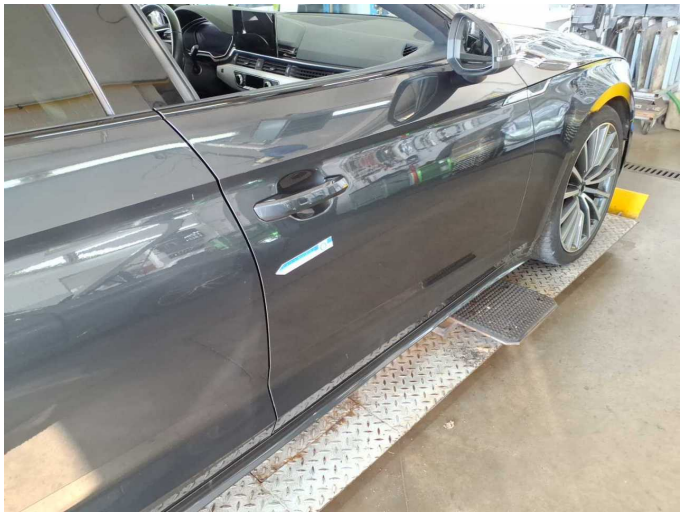
Damage 1: Equipment: Tirefit filler - Expired - Replace

Damage 2: Door - front right side: Door - dent(s) - Smooth repair work

Damage 3: Side panel - rear right side: Side panel - Paint defect - Smart repair

Damage 4: Front bumper: Front bumper (Unterhalb) - Scratch(es) - Smart repair

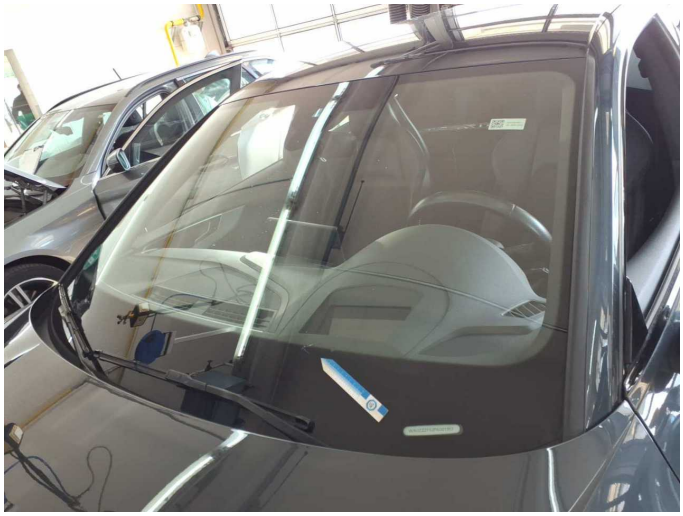
Damage 4: Front bumper: Front bumper (Unterhalb) - Scratch(es) - Smart repair

Damage 5: Vehicle glazing: Windscreen with lane departure assistant - Stone chips - Replace

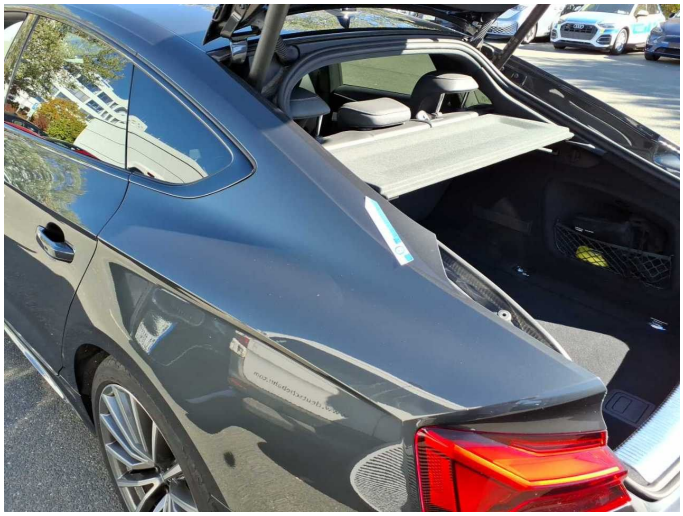
Wear and tear 1: Door - front right side: Door handle - outside - Scratch(es) - Cover / polish

Wear and tear 2: Roof: Roof - dent(s) - No deduction

Wear and tear 3: Side panel - rear left side: Side panel - dent(s) - No deduction

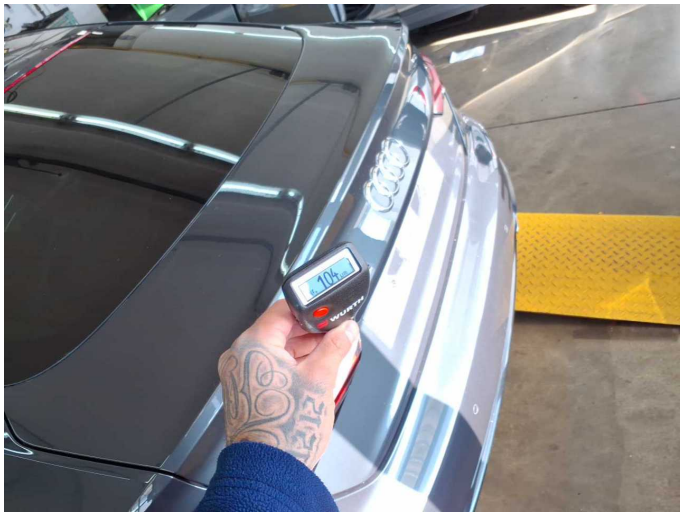
Previous damage 1: Front

Previous damage 2: Rear, Side right

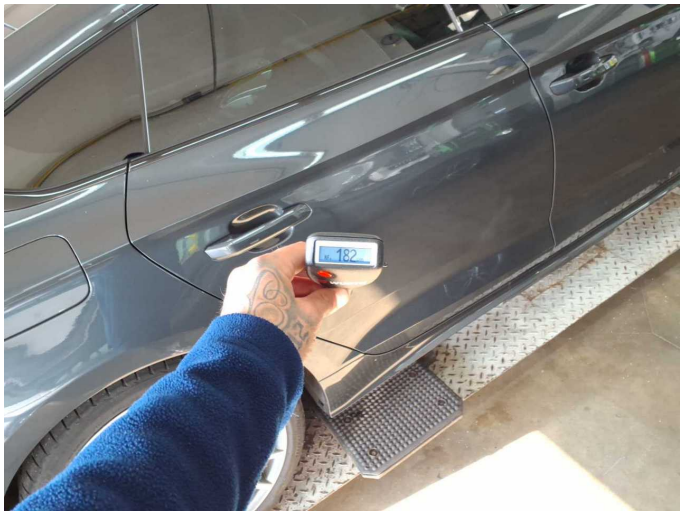
Previous damage 2: Rear, Side right

Repainting 1: Side panel - rear right side
