ARVAL
BNP PARIBAS GROUP

2CVM106

INSPECTION REPORT

End of contract

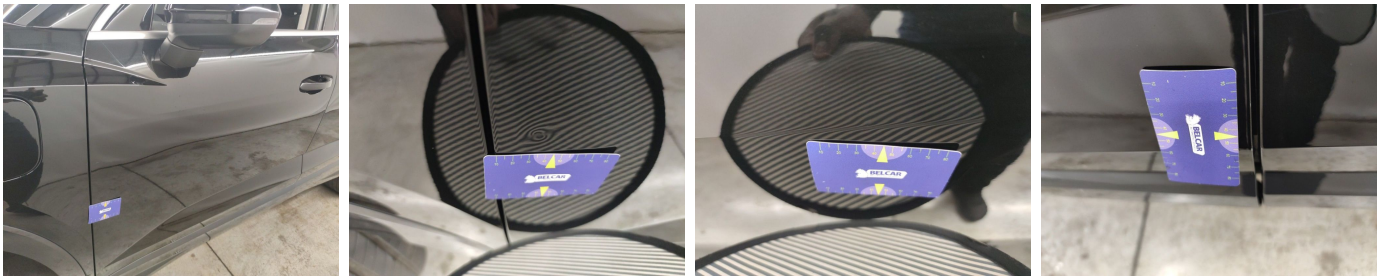
Door Rear Left // Polish-scratch

Door Front Left // Smart Repair Small-scratch + dent

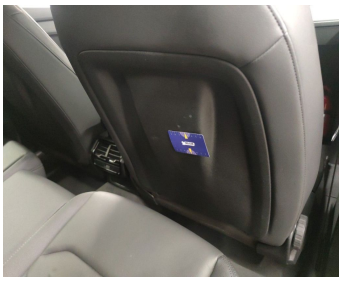
Wing Front Left // Repair & Painting-scratch + dent

Seat Front Right // Repair-scratch

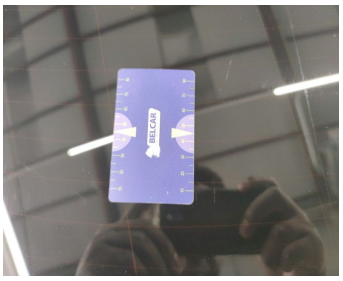
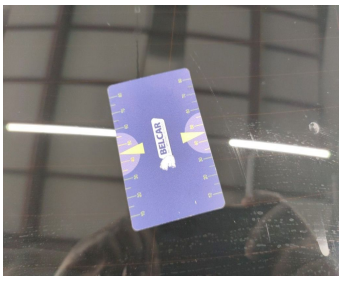
Door Front Right // Painting-scratch

Rear Bonnet / Rear Window / Replace-scratch

Rear Bonnet // Painting-scratch

Wing Rear Right // Smart Repair Medium-bad repair
