Expertise

Protocol number: 47962535
Order No. / Reference: 26826145
Inspection date: 6 Oct 2026

Manufacturer: Mercedes-Benz	Model: C 200 d T 9G-TRONIC Avantgarde
VIN: W1KAH0DB5PF101475

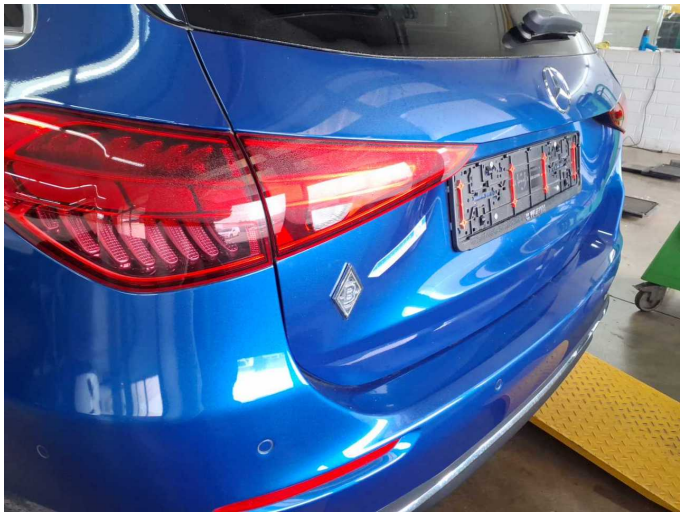
Damage 7: Boot lid / rear door: Boot lid - Glued / labelled - De-glue / neutralise

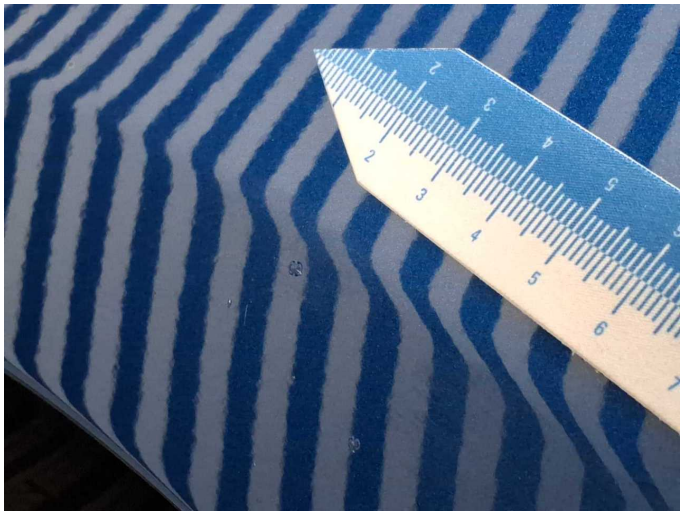
Damage 11: Side panel - rear left side: Side panel - Scratch(es) - Smart repair

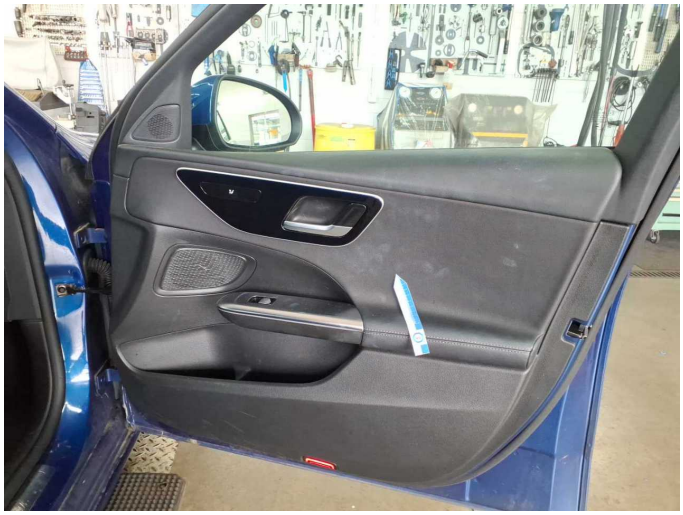
Damage 12: Interior: Interior - Soiled - Clean

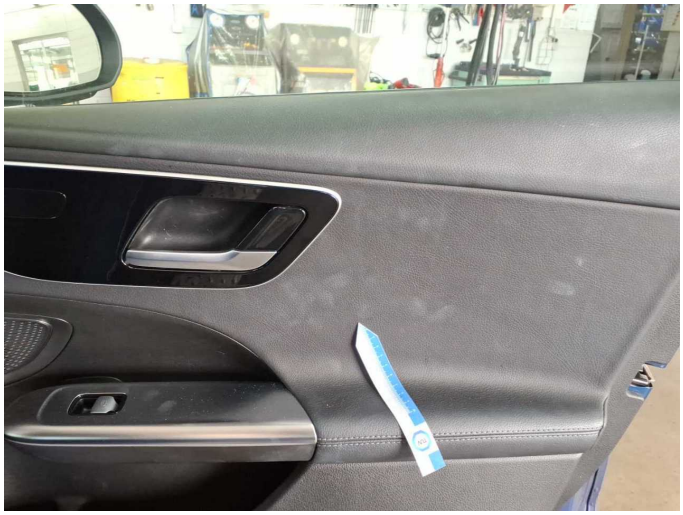
Damage 12: Interior: Interior - Soiled - Clean

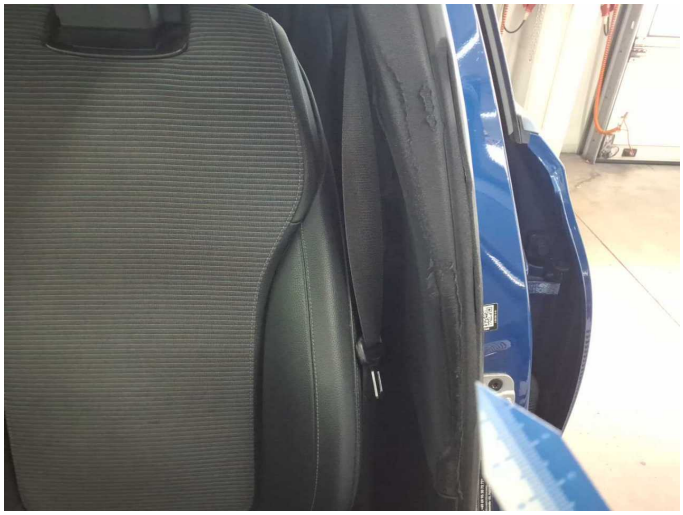
Damage 12: Interior: Interior - Soiled - Clean

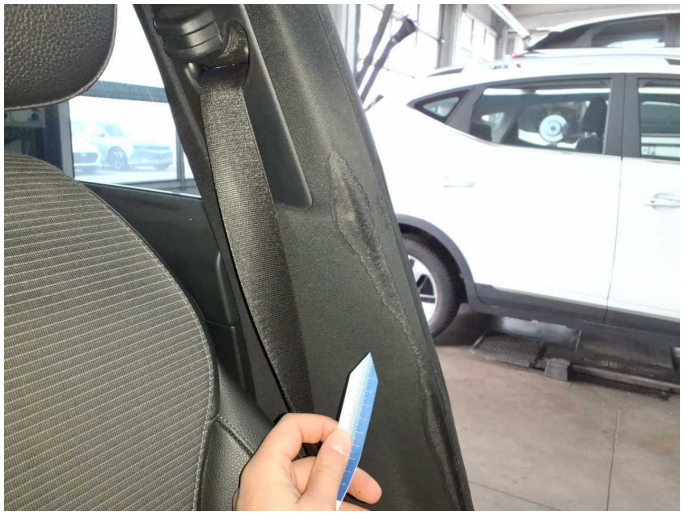
Damage 13: Trim / covers: B-pillar - trim - interior, left side - Scratched - Replace
