TÜV SÜD Auto Partner GmbH
Wiesenring 2
04159 Leipzig

Besichtigungsdatum: 24.09.2026
Protokollnummer: 48020688
Erstellt durch: Markus Böttcher
Besichtigt durch: Philipp Vitzthum

TMAH351DGNJ194377

Zustandsbericht

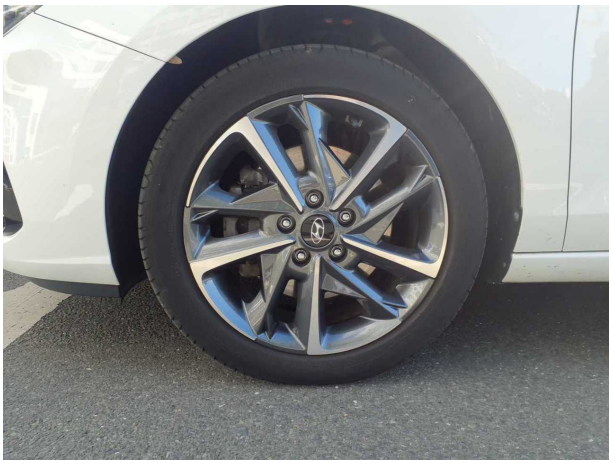
Abbildung 6: Montierte Bereifung

Achse	Reifengröße	Hersteller	Reifentyp	Profiltiefe	Verktgl.	Zul.
1	225/45 R17 91W	Michelin	Sommerreifen	5mm - 5mm	i.O.	i.O.
2	225/45 R17 91W	Michelin	Sommerreifen	5mm - 5mm	n.i.O.	i.O.

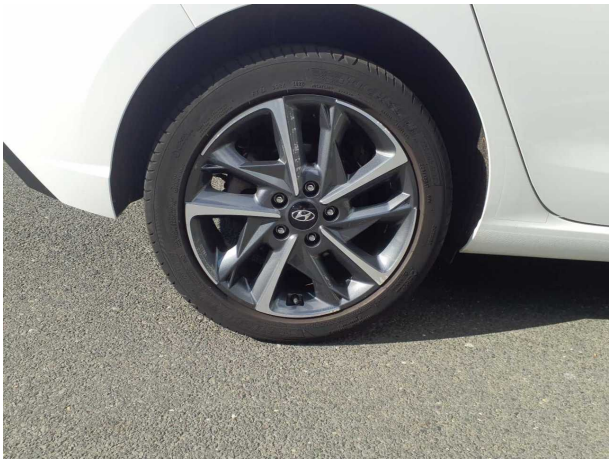
Nr.	Bauteilgruppe	Beschreibung
1	Rad/Reifen	Reifen hinten rechts - beschädigt - erneuern
2	Sonstiges	Inspektion/Wartung (01/2026 - kein Nachweis - Garantieverlust) - entspricht nicht den Herstellervorgaben

Beschädigung #1: Rad/Reifen: Reifen hinten rechts - beschädigt - erneuern
