Expertise

Protocol number: 48092823
Order No. / Reference: 27089788
Inspection date: 13 Oct 2026

Manufacturer: Audi	Model: A3 35 TDI Sportback S tronic S line
VIN: WAUZZZGY7RA128141

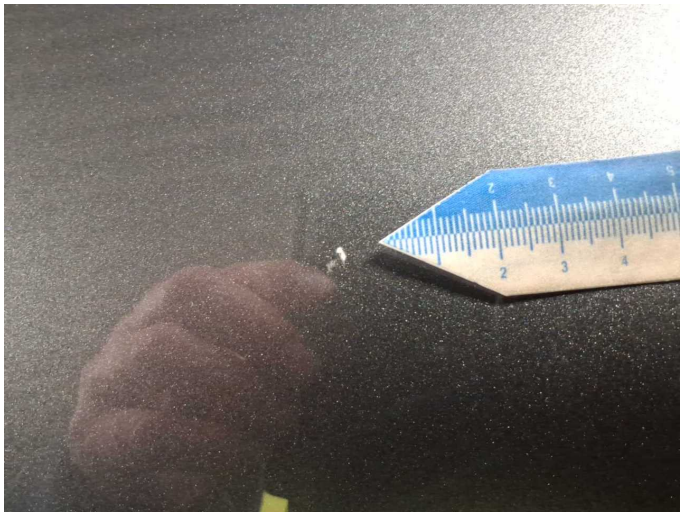
Damage 1: Rear bumper: Rear bumper - Scratch(es) - Smart repair
