VOLKSWAGEN ARTEON

Vehicle information

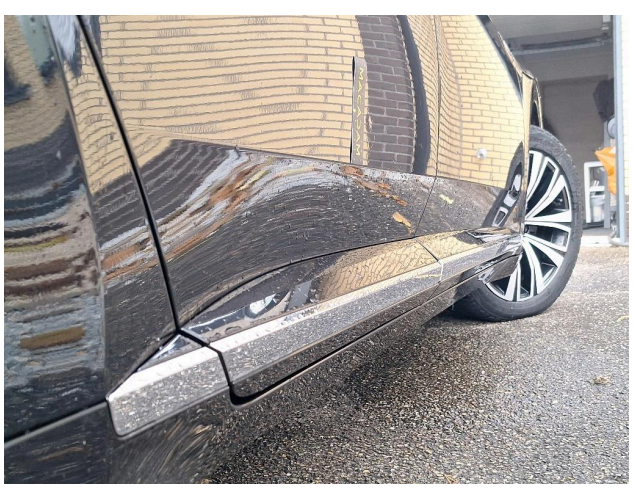
Bodywork

Damaged -

Acceptable.
