TÜV SÜD Auto Partner GmbH
Wiesenring 2
04159 Leipzig

Expertise

Protocol number: 48208238
Order No. / Reference: 27038587
Inspection date: 16 Oct 2026

Manufacturer: Mercedes-Benz	Model: C 200 d T 9G-TRONIC Avantgarde
VIN: W1KAH0DB6PF124621

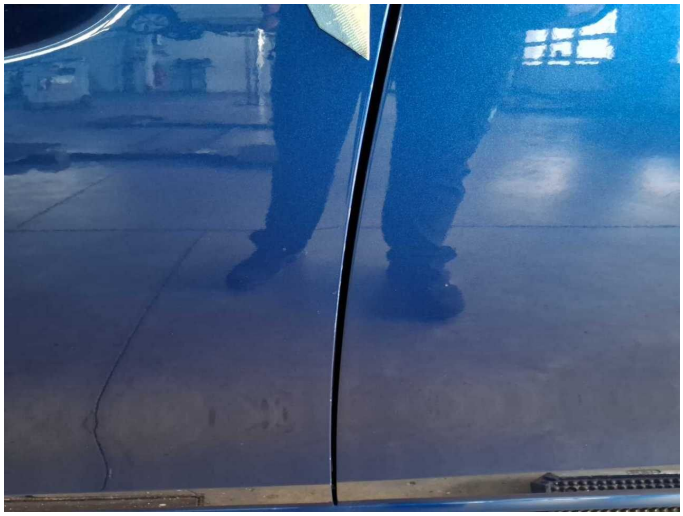
Damage 2: Door - front left side: Door edge - Scratch(es) - Smart repair

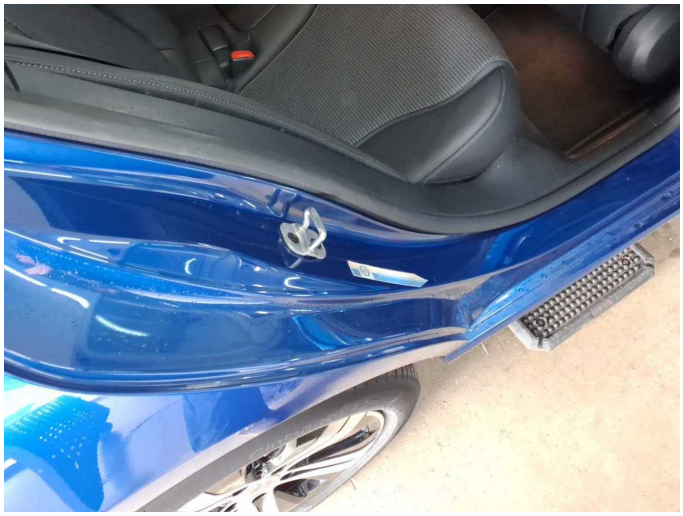
Damage 3: Side panel - rear right side: Sill - Dent / paintcoat damage - Smart repair

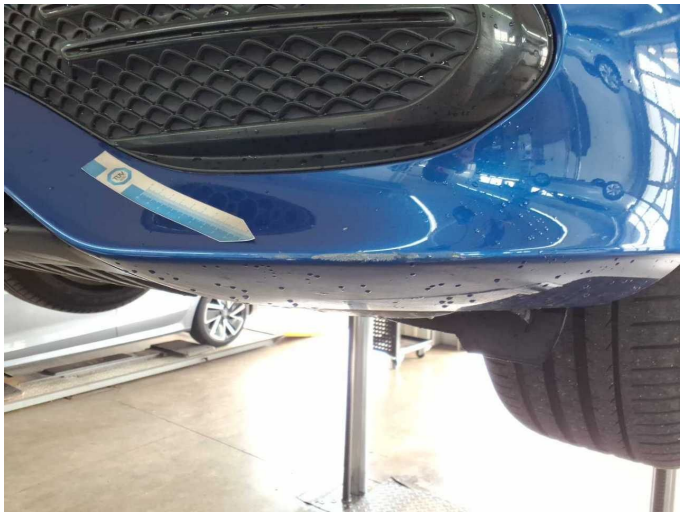
Damage 4: Rear bumper: Rear bumper - Scratch(es) - Paint

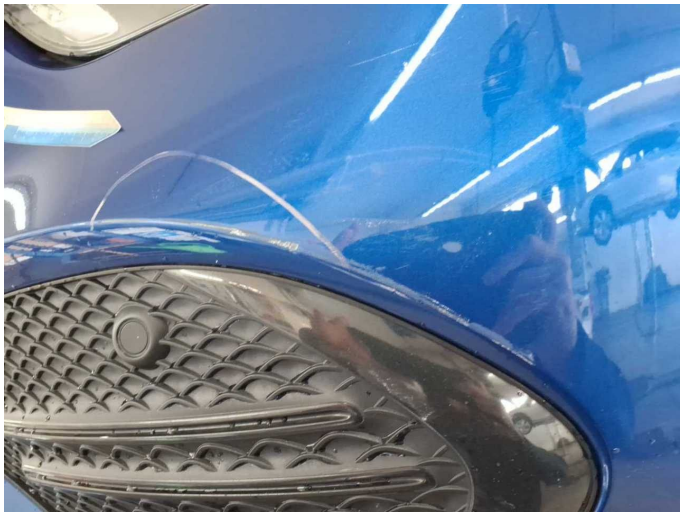
Damage 5: Front bumper: Front bumper - Scratched - Repair and paint
