TÜV SÜD Auto Partner GmbH
Wiesenring 2
04159 Leipzig

Expertise

Protocol number: 48575298
Order No. / Reference: 27162676
Inspection date: 6 Nov 2026

Manufacturer: Opel	Model: Astra Sports Tourer 1.5 D Automatik Business Edition
VIN: VXKFCYHZTP1057791

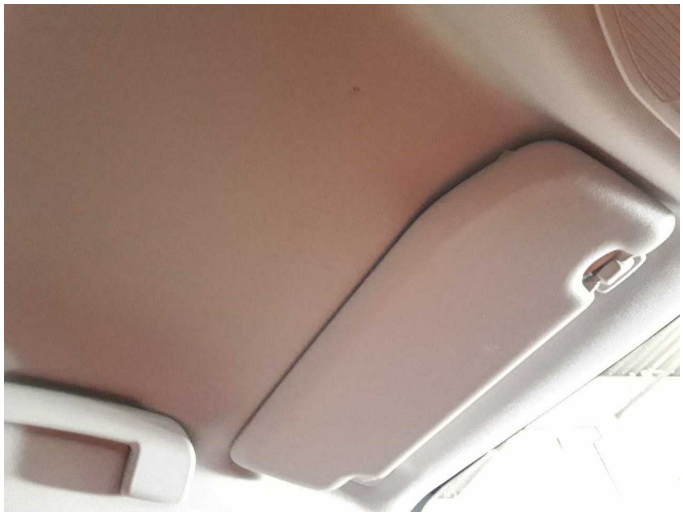
No.	Component group	Description
1	Side panel - rear right side	Side panel - Scratch(es) - Smart repair
2	Rear bumper	Rear bumper - Scratch(es) - Smart repair
3	Side panel - rear left side	Side panel - Scratch(es) - Smart repair
4	Trim / covers	Roof lining - Burn hole (cigarettes) - Smart repair
5	Engine	Engine - Leaking - Perform diagnosis
6	2nd wheel set	1 alloy rim - Scratch(es) - Loss in value

Damage 3: Side panel - rear left side: Side panel - Scratch(es) - Smart repair
