Expertise

Protocol number: 47935564
Order No. / Reference: 27104714
Inspection date: 5 Oct 2026

Manufacturer: Mercedes-Benz	Model: C 200 d T 9G-TRONIC Avantgarde
VIN: W1KAH0DB8PF070318

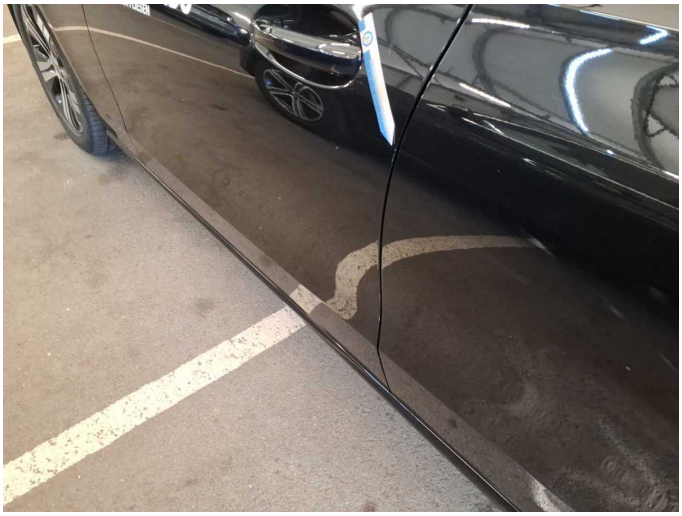
Damage 1: Side panel - rear right side: Side panel - dent(s) - Smooth repair work

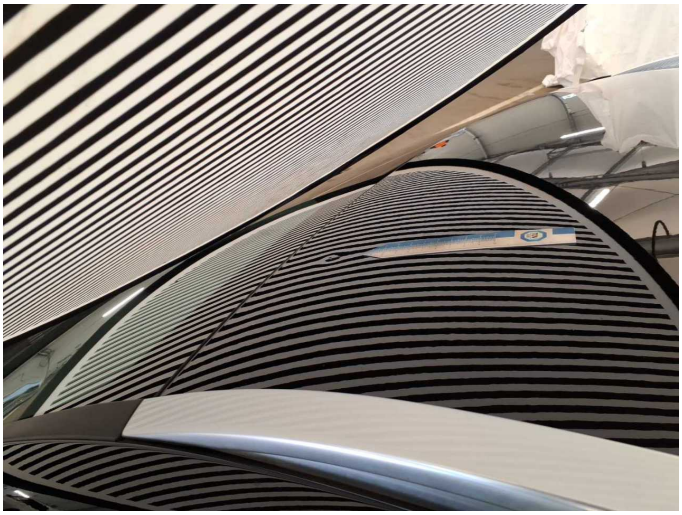
Damage 3: Roof: Roof - dent(s) - Smooth repair work

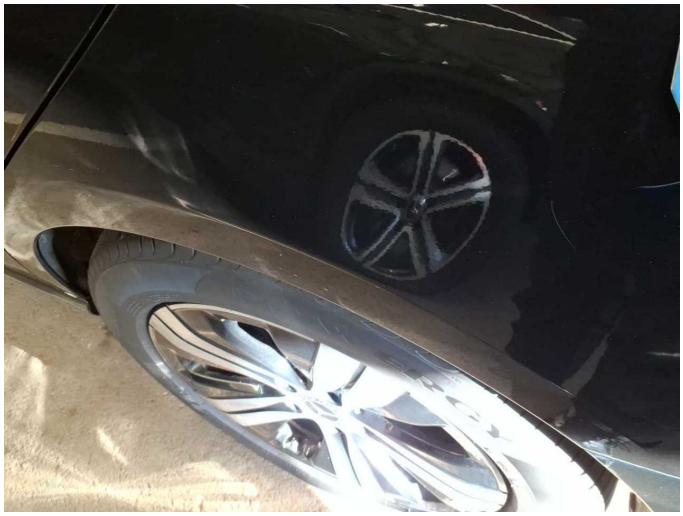
Damage 4: Body: Body - Glued / labelled - De-glue / neutralise

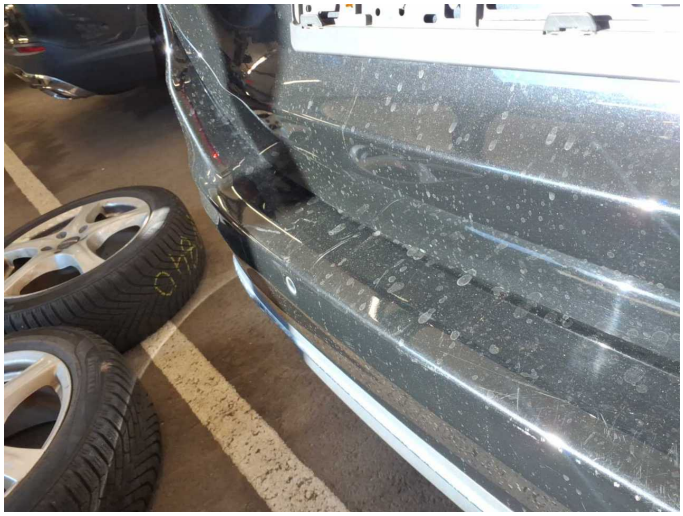
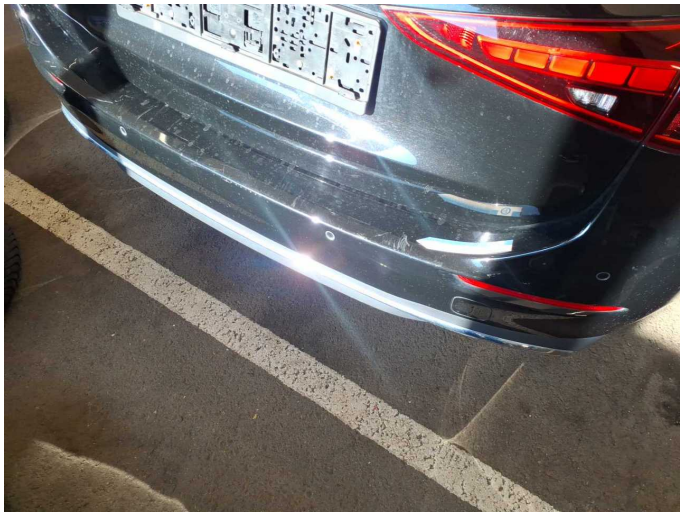
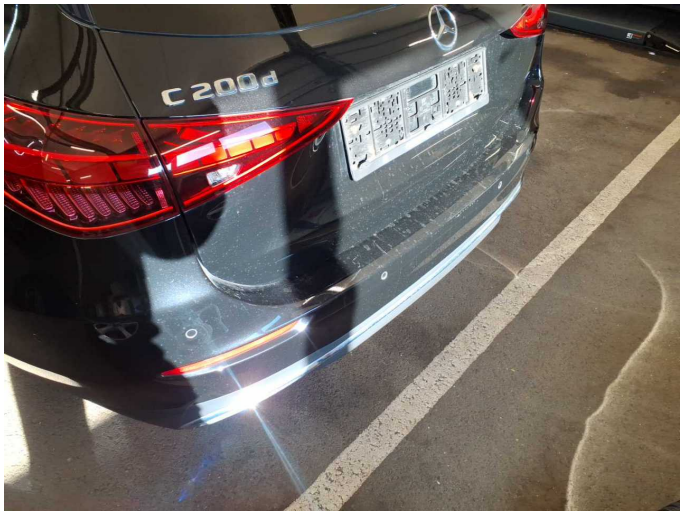
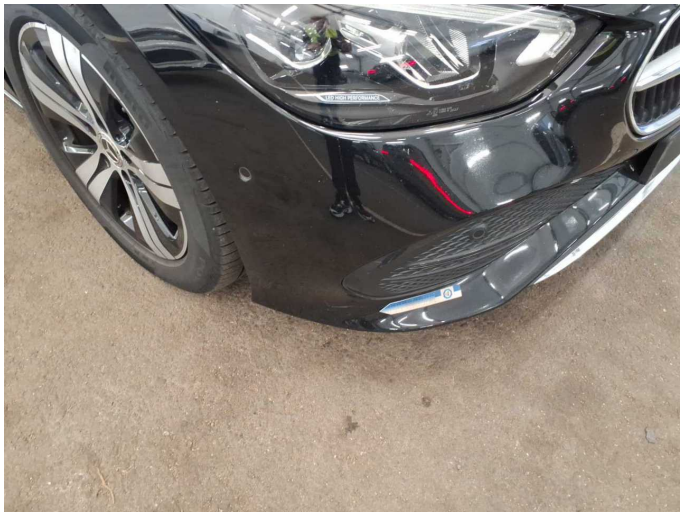
Damage 9: Rear bumper: Rear bumper - Scratch(es) - Paint

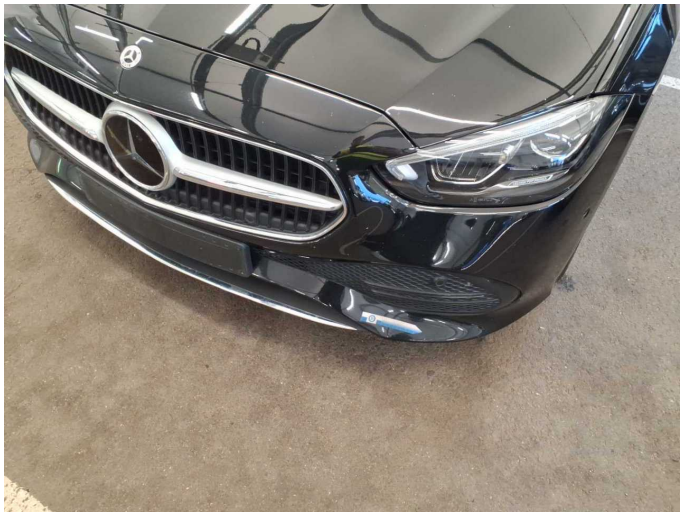
Damage 10: Front bumper: Front bumper - Scratch(es) - Paint
