Expertise

Protocol number: 48456432
Order No. / Reference: 27211120
Inspection date: 2 Nov 2026

Manufacturer: Opel	Model: Combo Cargo 1.5 D EHZ Selection
VIN: W0VEFYHT2NJ588330

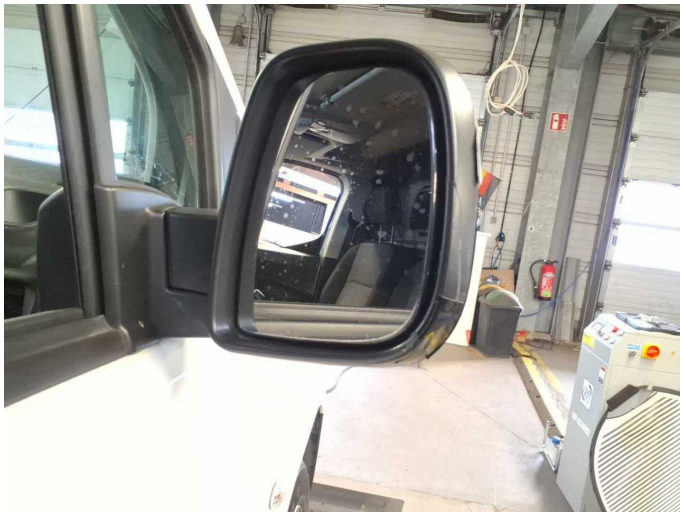
No.	Component group	Description
1	Door - front left side	Door (Griffmulde) - Scratched - Smart repair
2	Side panel - rear left side	Side panel - dent(s) - Smooth repair work
3	Trim / covers	Door trim - front right side - Scratched - Loss in value
4	Wing mirror - right side	Wing mirror (Glas ganz) - Damaged - Replace
5	Door - rear right side	Door - Scratched - Paint

Damage 4: Wing mirror - right side: Wing mirror (Glas ganz) - Damaged - Replace
