Expertise

Protocol number: 48444901
Order No. / Reference: 27257769
Inspection date: 30 Oct 2026

Manufacturer: Volkswagen	Model: Touran 2.0 TDI SCR DSG Comfortline
VIN: WVGZZZ1TZNW005363

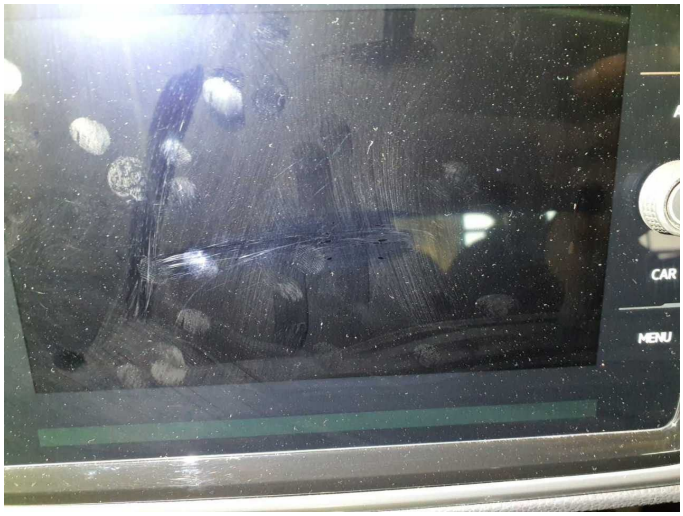
Damage 4: Multimedia system: Screen - Scratch(es) - Loss in value

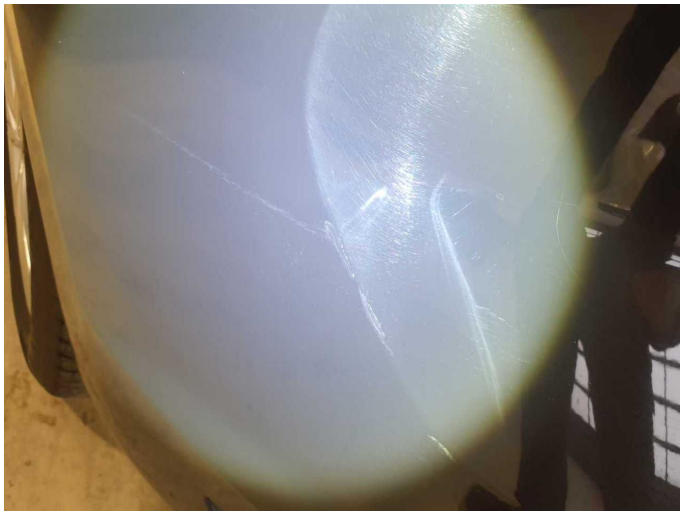
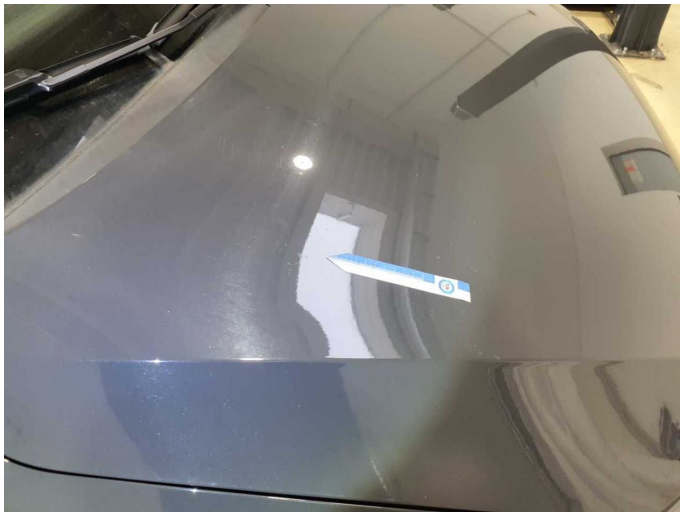
Damage 5: Rear bumper: Rear bumper - Scratch(es) - Paint
