Expertise

Protocol number: 48155403
Order No. / Reference: 27083981
Inspection date: 30 Sept 2026

Manufacturer: Ford	Model: Transit Custom 320 L2H1 LKW VA Trend
VIN: WF0YXXTTGYNA74875

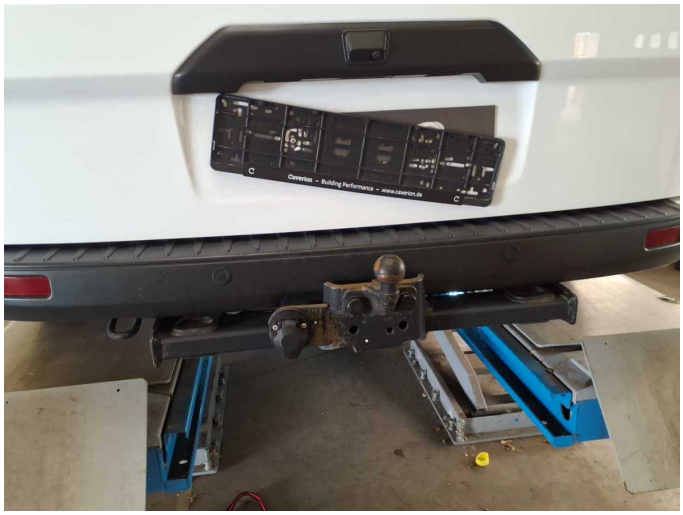
No.	Component group	Description
1	Boot lid / rear door	Boot lid - Scratch(es) - Paint
2	Roof	Roof - Corrosion - Repair and paint

Damage 2: Roof: Roof - Corrosion - Repair and paint
