TÜV SÜD Auto Partner GmbH
Wiesenring 2
04159 Leipzig

# Expertise

Protocol number: 48117038
Order No. / Reference: 27108731
Inspection date: 14 Oct 2026

| Manufacturer: Ford | Model: Galaxy 2.0 EcoBlue S&S Aut. TITANIUM |

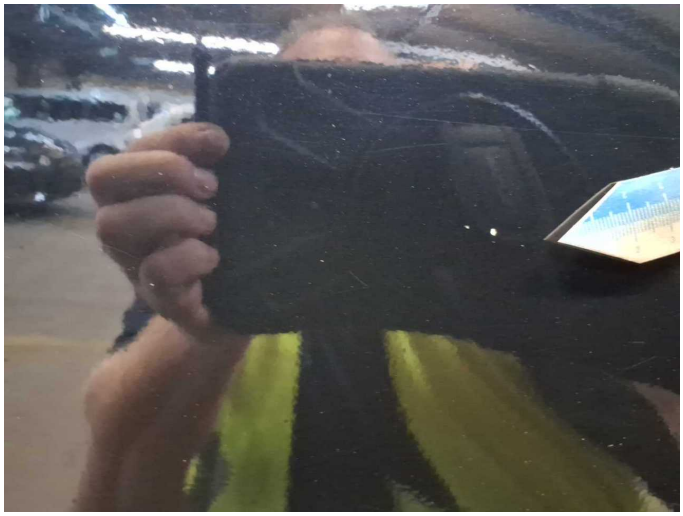
| No. | Component group | Description |
|---|---|---|
| 3 | Door - rear left side | Door - Dent / paintcoat damage - Smart repair |

**Damage 3:** Door - rear left side: Door - Dent / paintcoat damage - Smart repair

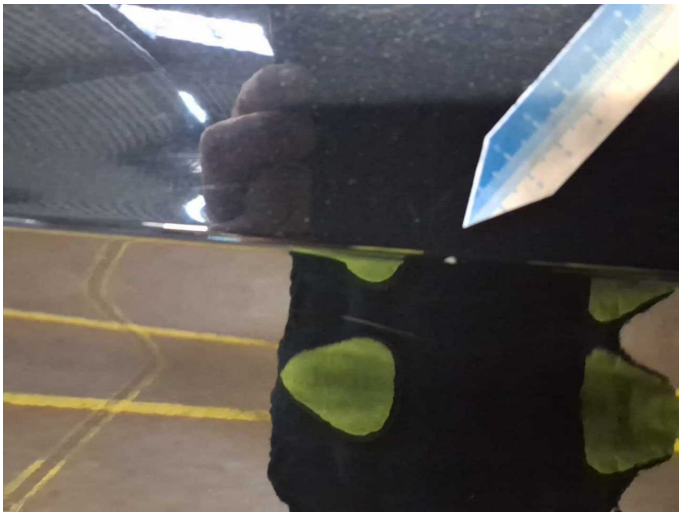
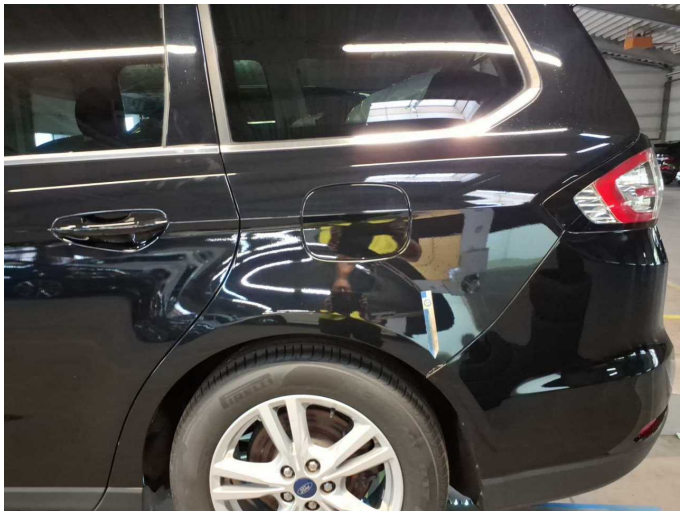
| No. | Component group | Description |
|---|---|---|
| 5 | Door - rear right side | Door (unterhalb) - Scratch(es) - Paint |

**Damage 5:** Door - rear right side: Door (unterhalb) - Scratch(es) - Paint

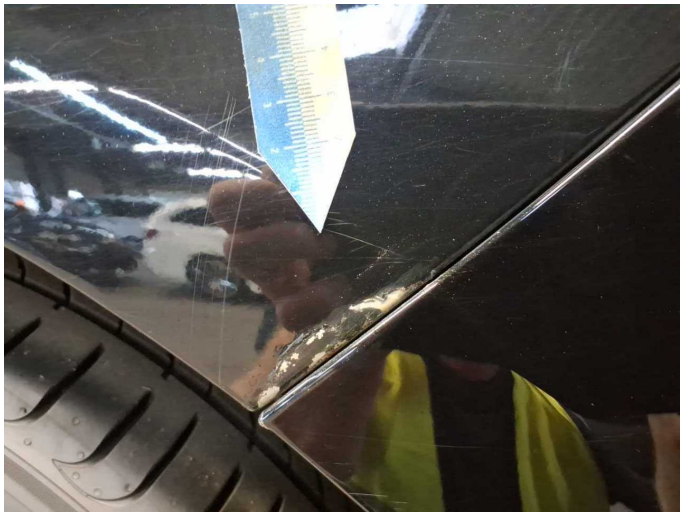
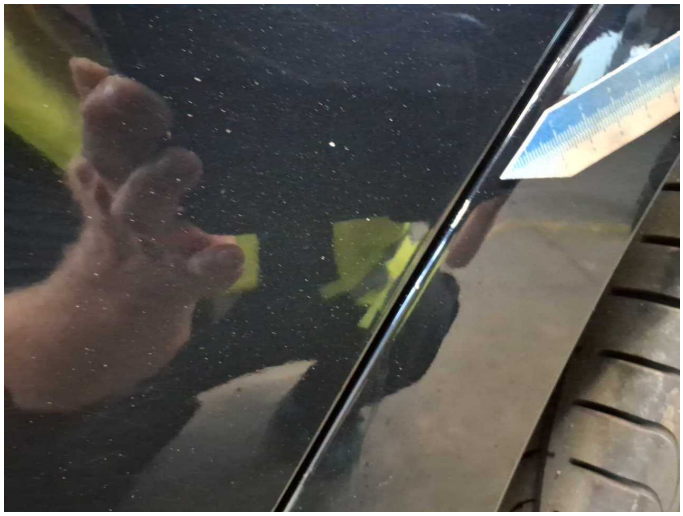
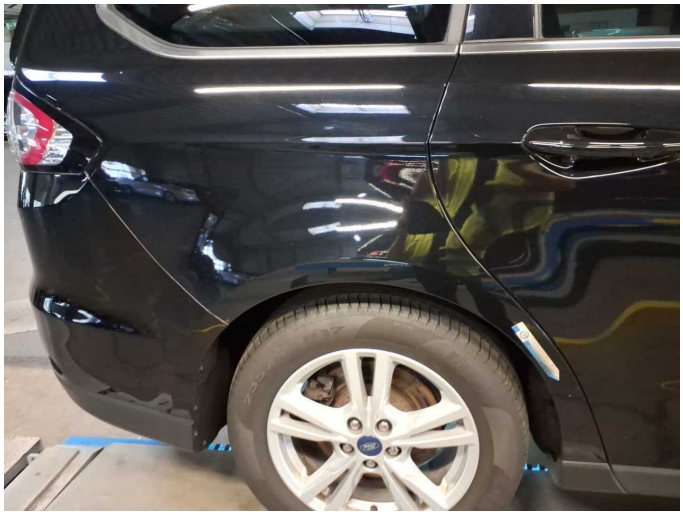
| No. | Component group | Description |
|---|---|---|
| 6 | Side panel - rear left side | Side panel (unterhalb) - Paint defect - Paint |

**Damage 6:** Side panel - rear left side: Side panel (unterhalb) - Paint defect - Paint

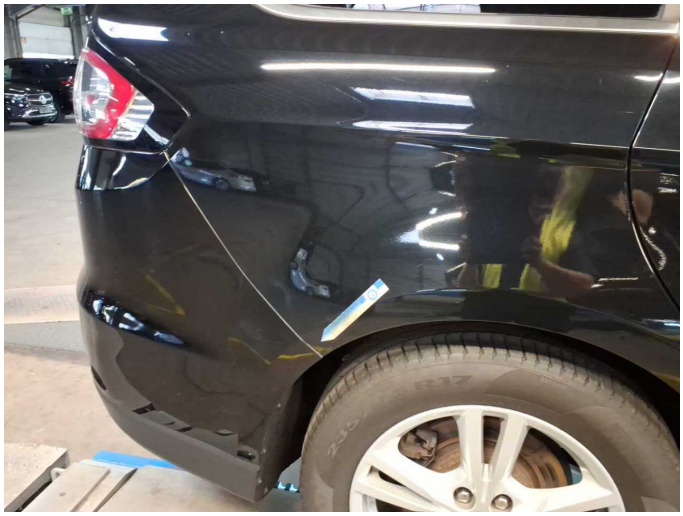
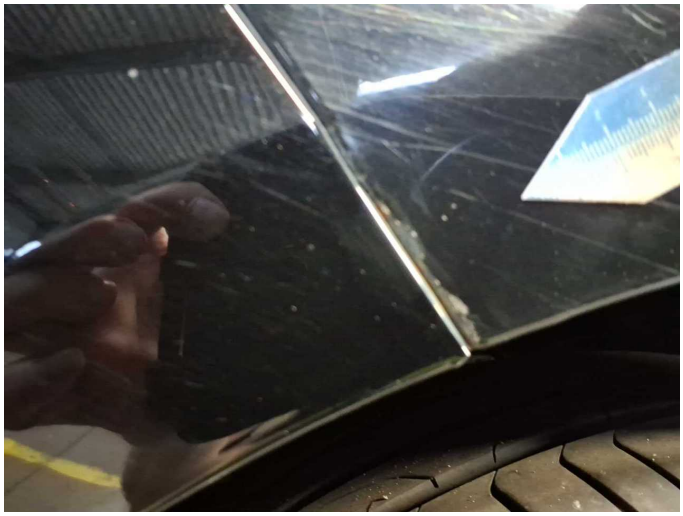
| No. | Component group | Description |
|---|---|---|
| 7 | Side panel - rear right side | Side panel (unterhalb) - Scratch(es) - Paint |

**Damage 7:** Side panel - rear right side: Side panel (unterhalb) - Scratch(es) - Paint

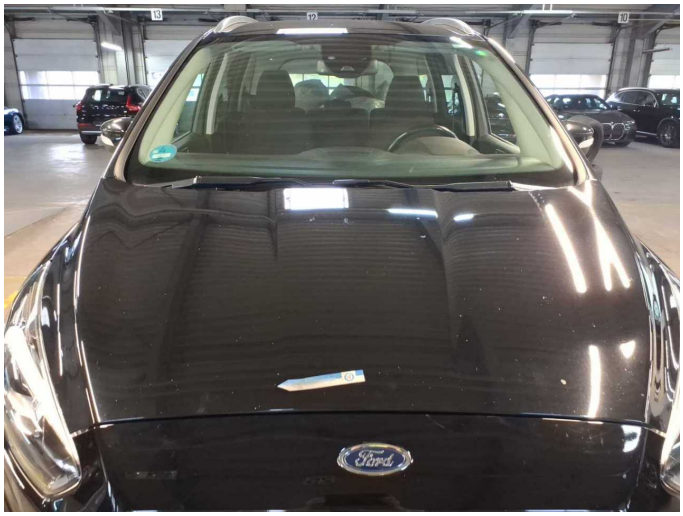
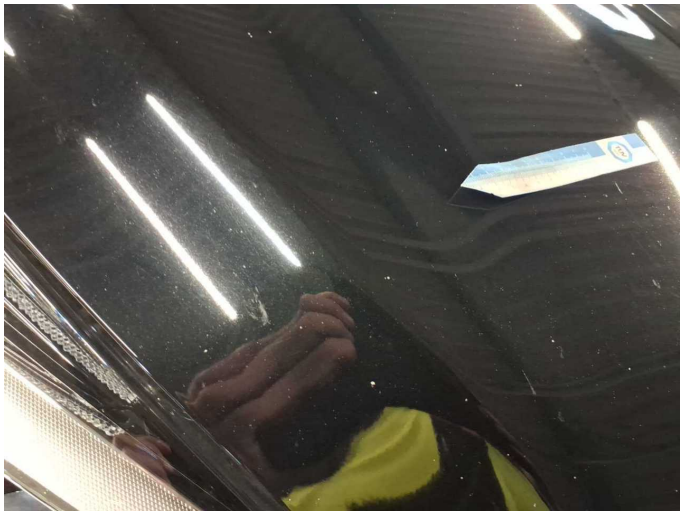
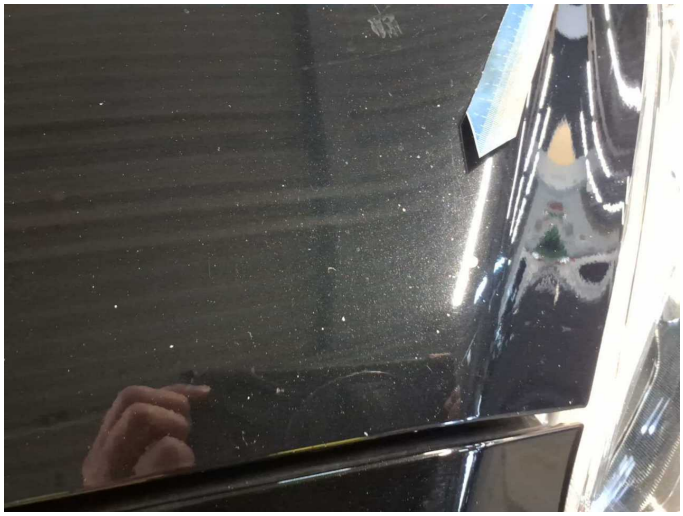
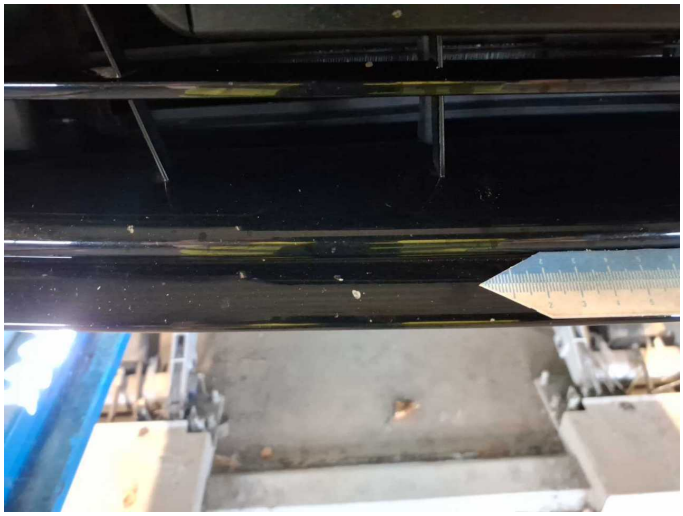
| No. | Component group | Description |
|---|---|---|
| 8 | Bonnet | Bonnet (Sandstrahleffekt) - Stone chips - Paint |

**Damage 8:** Bonnet: Bonnet (Sandstrahleffekt) - Stone chips - Paint

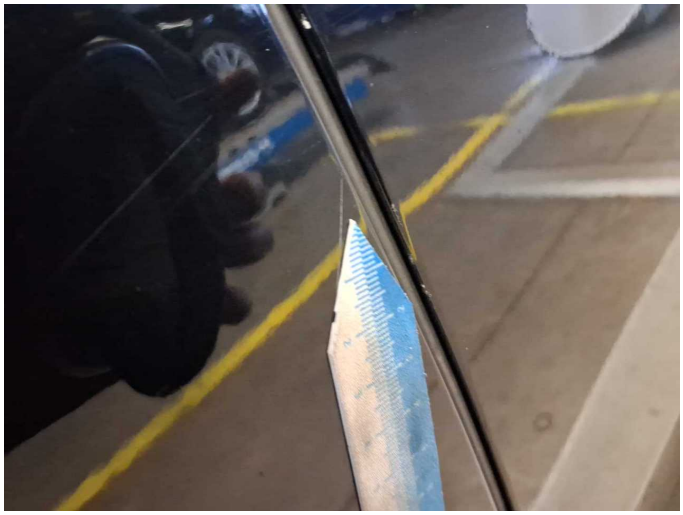
| No. | Component group | Description |
|---|---|---|
| 4 | Door - front right side | Door edge - Scratch(es) - Cover / polish |

**Wear and tear 4:** Door - front right side: Door edge - Scratch(es) - Cover / polish
