Expertise

Protocol number: 48016354
Order No. / Reference: 26986007
Inspection date: 8 Oct 2026

Manufacturer: Volkswagen	Model: Golf Variant 2.0 TDI SCR DSG R-Line
VIN: WVWZZZCD0RW808407

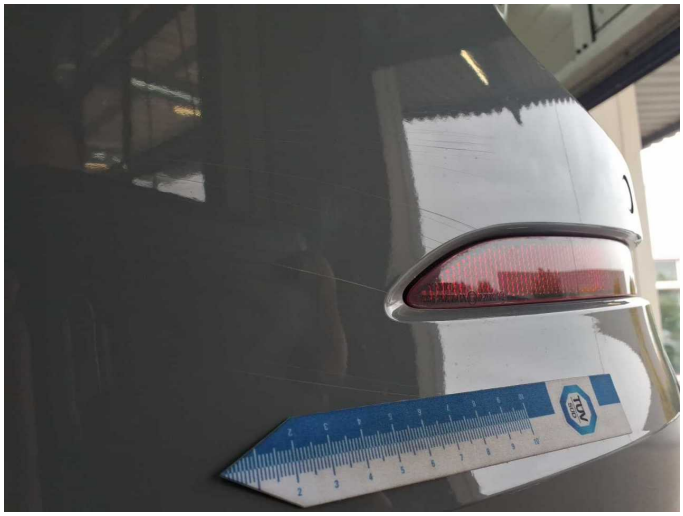
Damage 12: Rear bumper: Rear bumper - Scratch(es) - Paint
