TÜV SÜD Auto Partner GmbH
Wiesenring 2
04159 Leipzig

Expertise

Protocol number: 48587528
Order No. / Reference: 27251185
Inspection date: 9 Nov 2026

Manufacturer: Ford	Model: Focus Turnier 1.5 EcoBlue Start-Stopp-System Aut. TITANIUM
VIN: WF0PXXGCHPPT27532

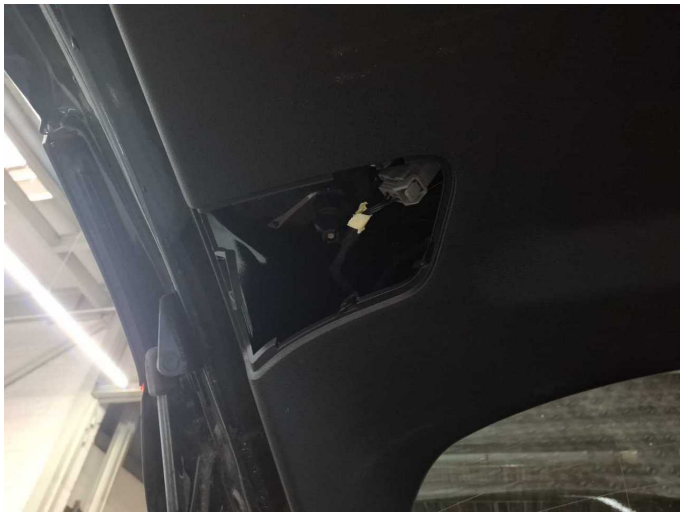
No.	Component group	Description
1	Trim / covers	Boot lid - interior trim (Abdeckung) - Broken / torn - Replace
2	Engine	Engine cover (Isolierung) - Damage caused by marten / rodent - Replace
3	Instrument panel	Indicator light (Reifendruckkontrollsystem) - on - Perform diagnosis
4	Roof	Roof (hinten) - Scratch(es) - Paint

Damage 1: Trim / covers: Boot lid - interior trim (Abdeckung) - Broken / torn - Replace

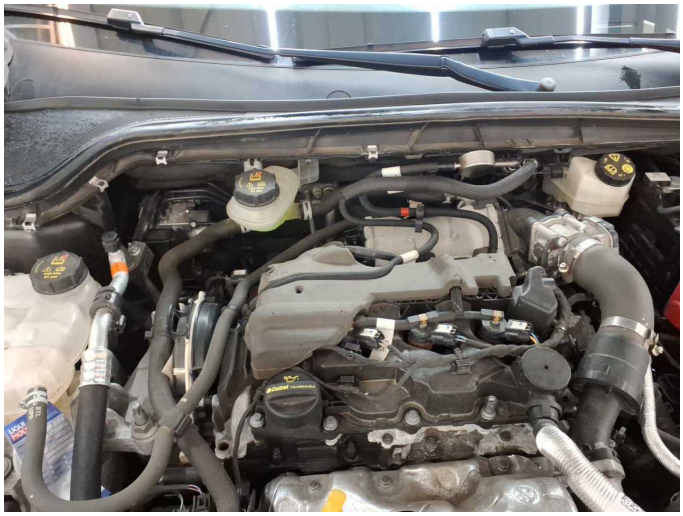
Marder Spuren sind im Motorraum, weitere Schäden sind möglich.

Damage 2: Engine: Engine cover (Isolierung) - Damage caused by marten / rodent - Replace
