Expertise

Protocol number: 48616330
Order No. / Reference: 27266107
Inspection date: 5 Nov 2026

Manufacturer: Mercedes-Benz	Model: 311 CDI Sprinter Kompakt HA
VIN: W1V9076311P214756

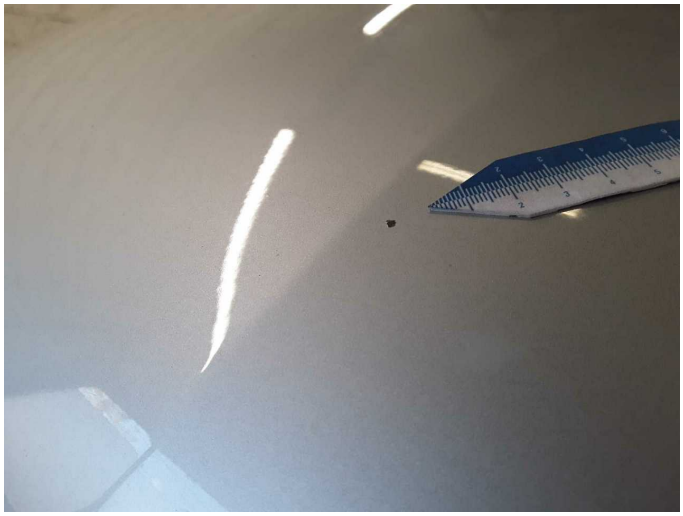
Damage 3: Body: B-pillar - right side - Dent / paintcoat damage - Repair and paint

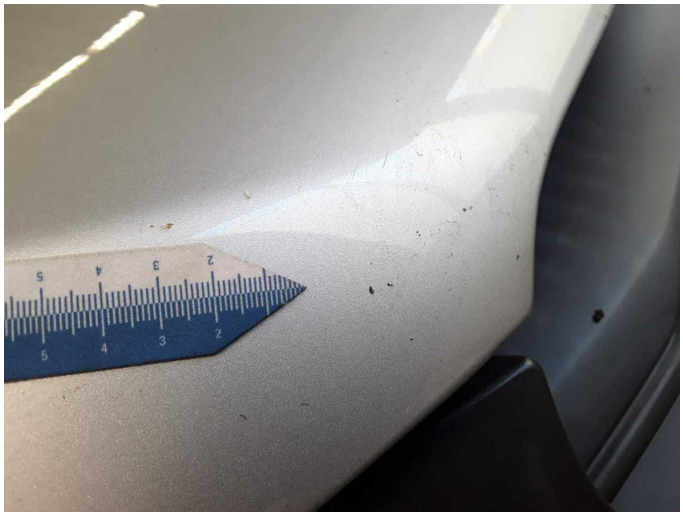
Damage 4: Bonnet: Bonnet - Stone chips - Paint

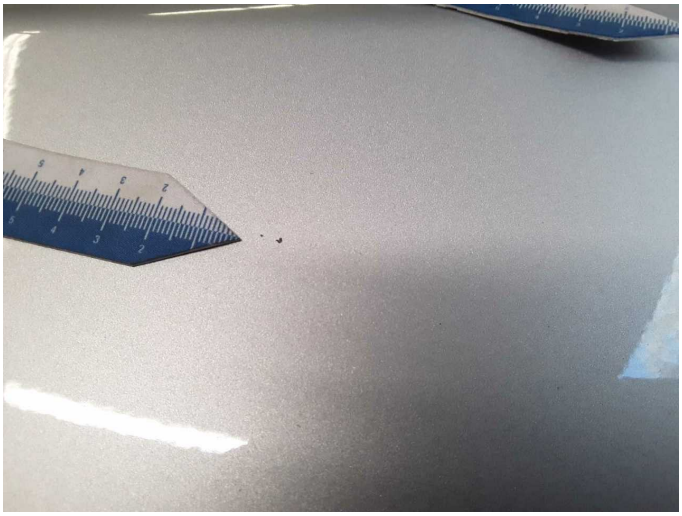
Damage 4: Bonnet: Bonnet - Stone chips - Paint

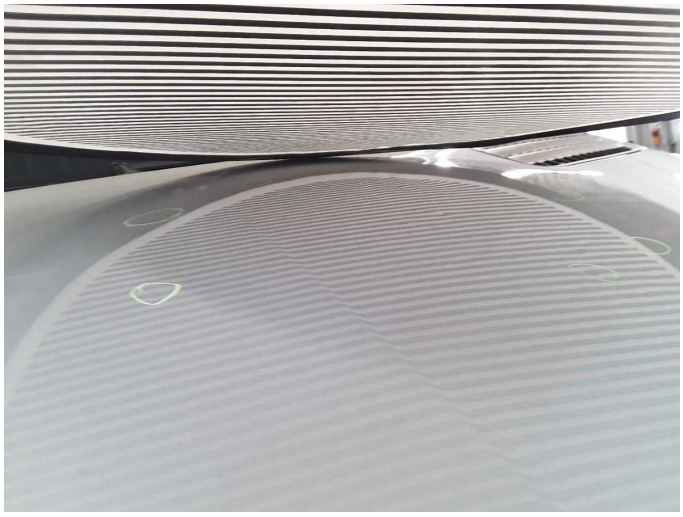
Damage 9: Body: Body - Damage by hail - repair according to calculation

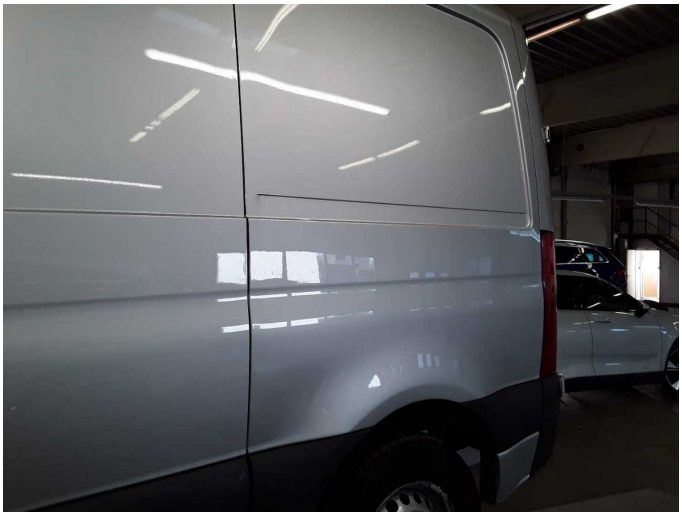
Side panel - rear left side	417 µm	Door - rear right side	400 µm

Repainting 1: Side panel - rear left side, Door - rear right side
