TÜV SÜD Auto Partner GmbH
Wiesenring 2
04159 Leipzig

Expertise

Protocol number: 48203905
Order No. / Reference: 27173550
Inspection date: 15 Oct 2026

Manufacturer: Audi	Model: Q5 50 TFSIe quattro S tronic advanced
VIN: WAUZZZFY8P2171184

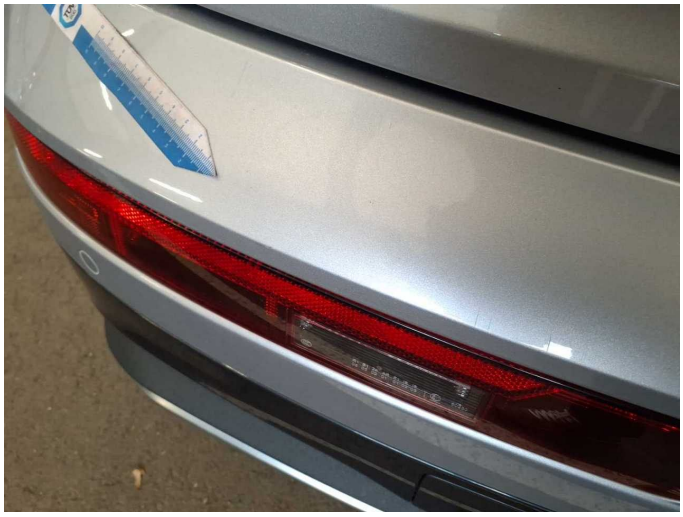
Damage 3: Rear bumper: Rear bumper - Scratched - Smart repair

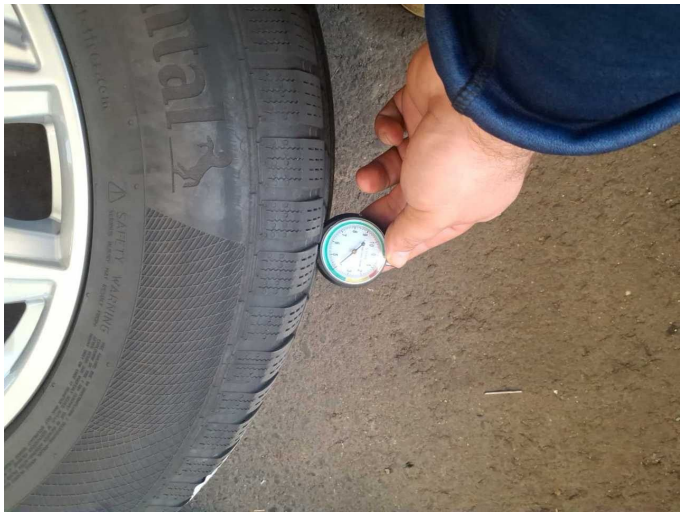
Damage 5: 2nd wheel set: 1 tyre - Does not meet the leasing specifications - Replace
