ARVAL
BNP PARIBAS GROUP

2EDS491

INSPECTION REPORT

End of contract

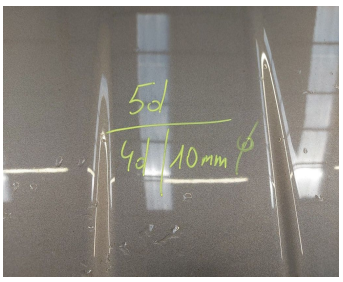
Bumper Front // Painting-scratch

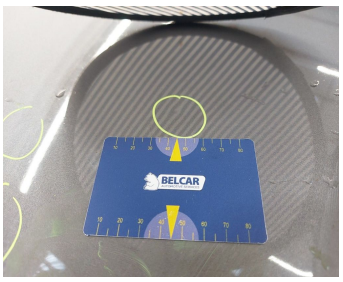
See External Expertise-dent

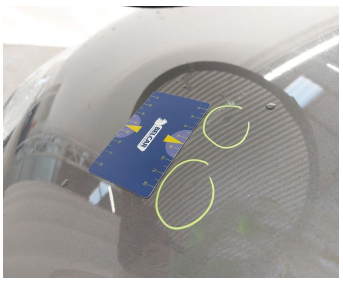
See External Expertise-dent
