Expertise

Protocol number: 48454634
Order No. / Reference: 27137309
Inspection date: 22 Oct 2026

Manufacturer: Audi	Model: A5 Sportback 40 TDI quattro S tronic advanced
VIN: WAUZZZF5XPA019483

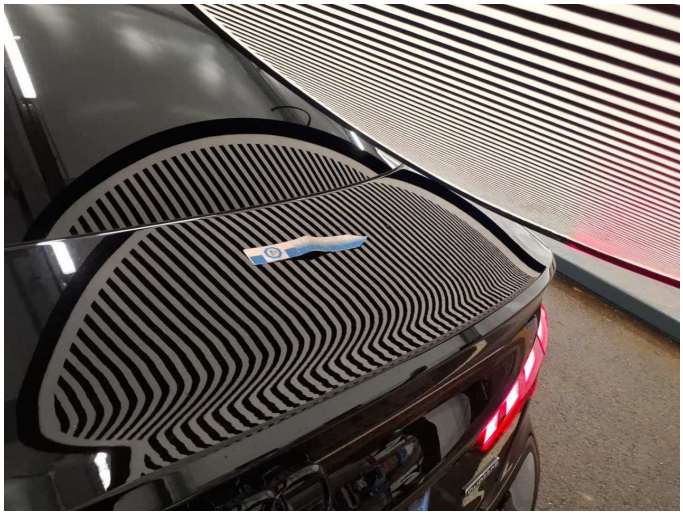
Damage 4: Boot lid / rear door: Boot lid - dent(s) - Smooth repair work

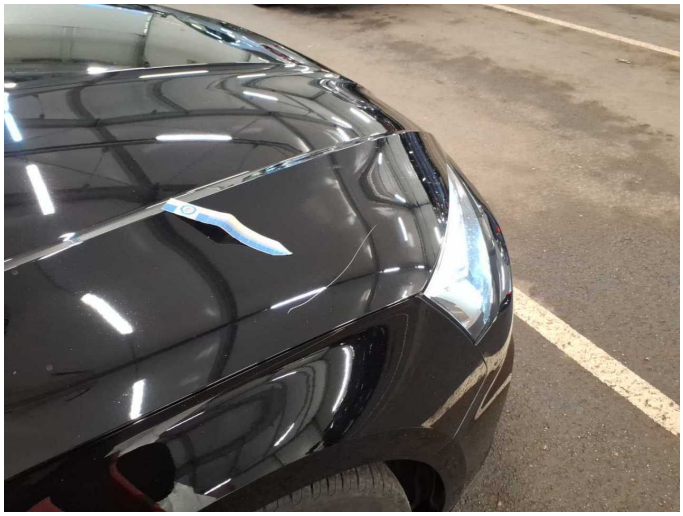
Damage 6: Bonnet: Bonnet - Scratched - Paint

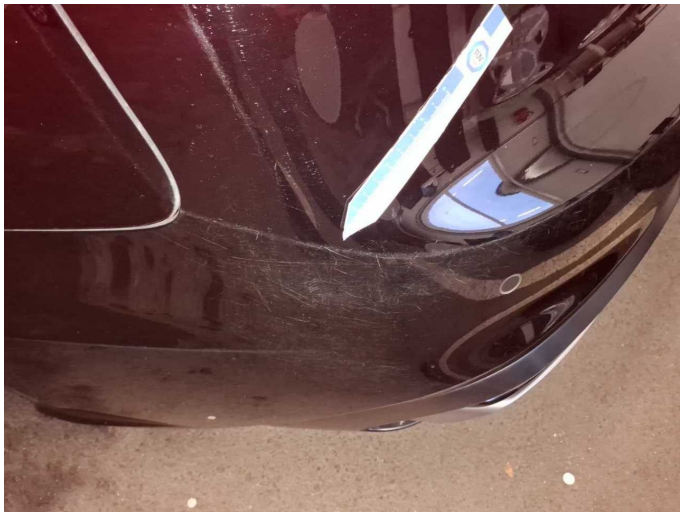
Damage 7: Rear bumper: Rear bumper - Scratch(es) - Paint

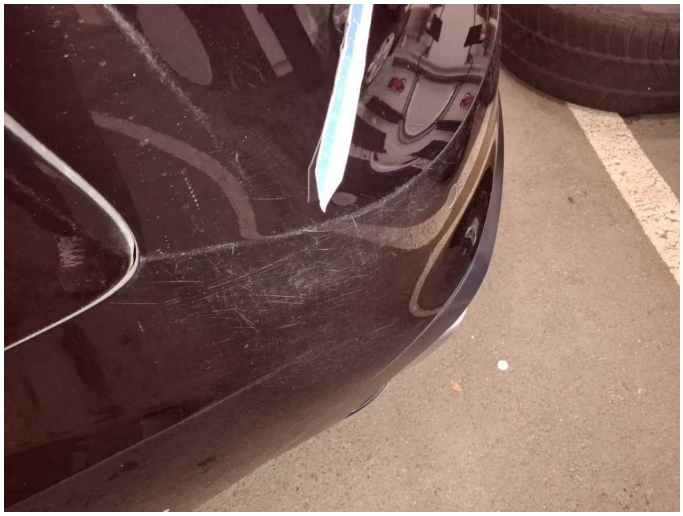
Damage 7: Rear bumper: Rear bumper - Scratch(es) - Paint
