APPRAISAL REPORT

Driver name:	ASSE I
Make:	AUDI
Model / version:	A6 FRONT
Wine:	WAUZZZF27PN025689
Plate:	2CTQ849
Mileage:	174043
SOH:	
First registration:	23/11/2022
Color:	FIRMAMENT BL

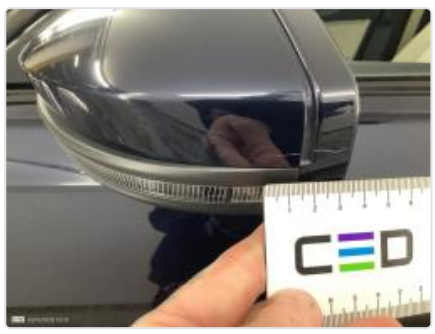
#	Rental	Damage type	Renta®	Repaired	Already invoiced
1	Bodywork	Damaged	✓	✗	✗
