Expertise

Protocol number: 48570873
Order No. / Reference: 27230036
Inspection date: 5 Nov 2026

Manufacturer: Mercedes-Benz	Model: B 180 d 8G-DCT Entry
VIN: W1K4F1AB9RJ619604

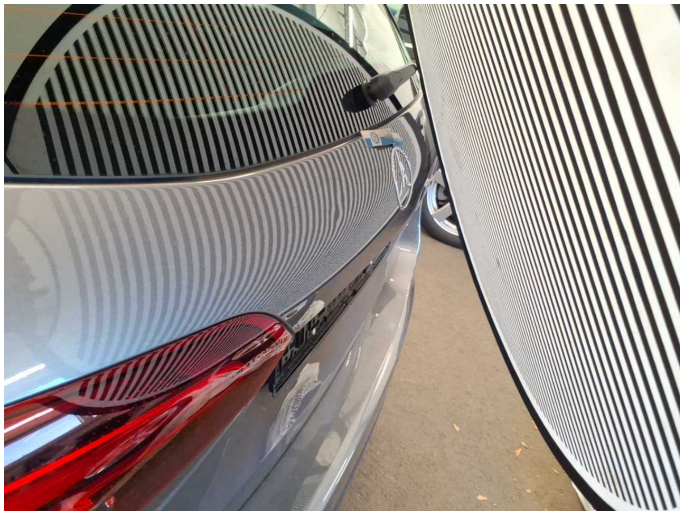
Damage 3: Boot lid / rear door: Boot lid - dent(s) - Smooth repair work

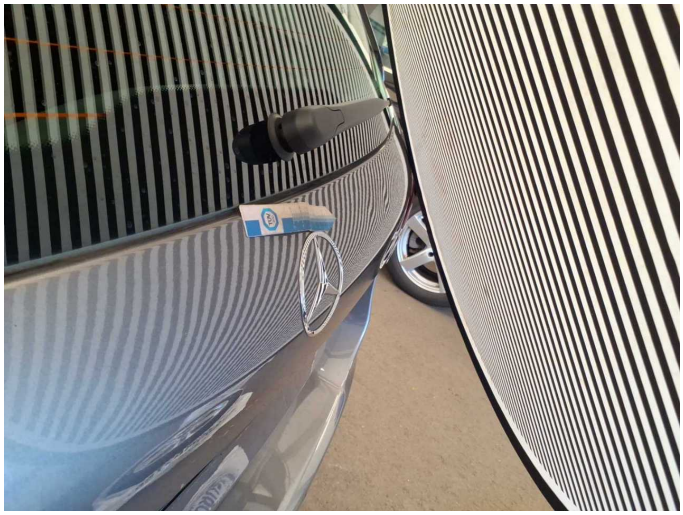
Damage 3: Boot lid / rear door: Boot lid - dent(s) - Smooth repair work

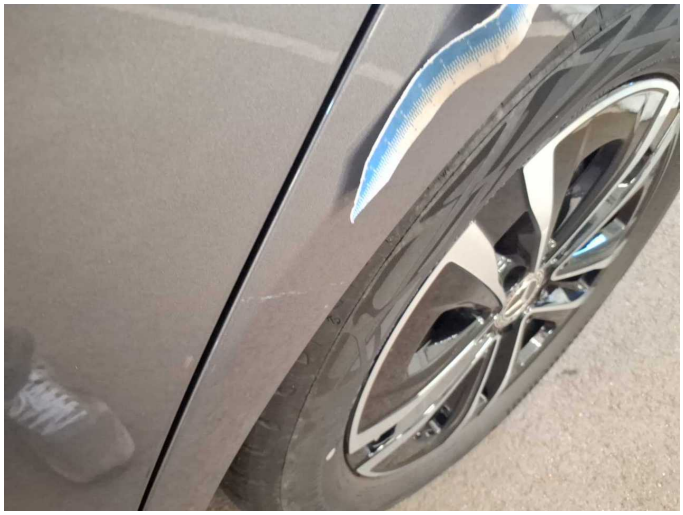
Damage 5: Side panel - rear left side: Side panel (Kniestück) - Scratch(es) - Smart repair

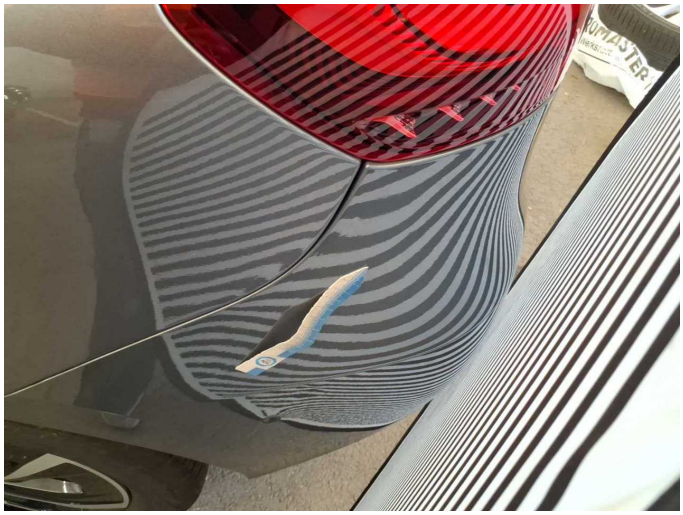
Wear and tear 2: Rear bumper: Rear bumper - dent(s) - No deduction
