Expertise

Protocol number: 48582895
Order No. / Reference: 27218393
Inspection date: 3 Nov 2026

Manufacturer: Skoda	Model: Superb Combi 2.0 TDI DSG Ambition
VIN: TMBJH7NPXP7014324

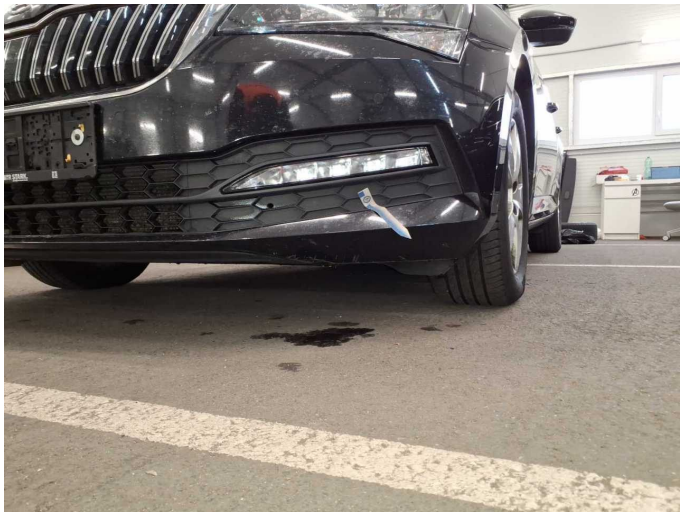
Damage 2: Front bumper: Front bumper - Scratched - Smart repair

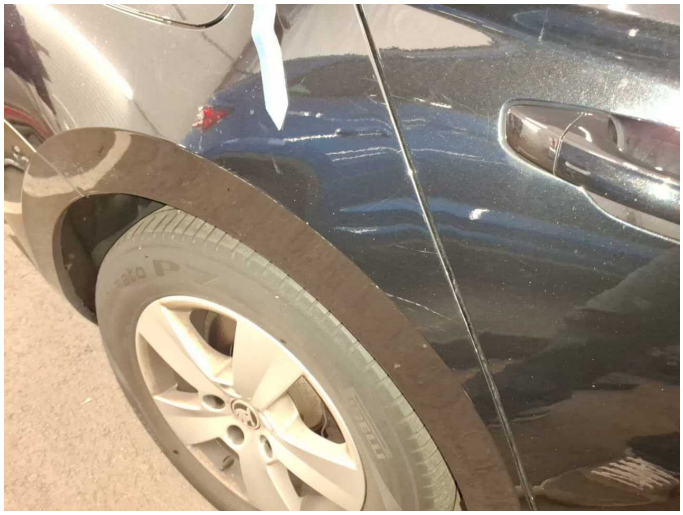
Damage 3: Side panel - rear right side: Side panel - Scratch(es) - Paint

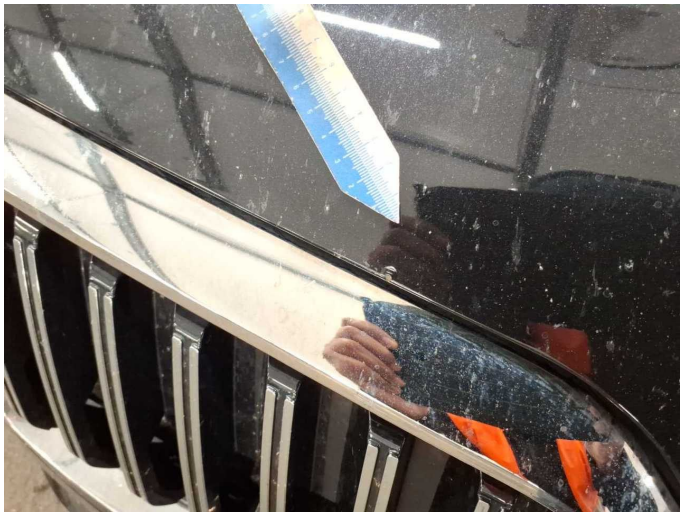
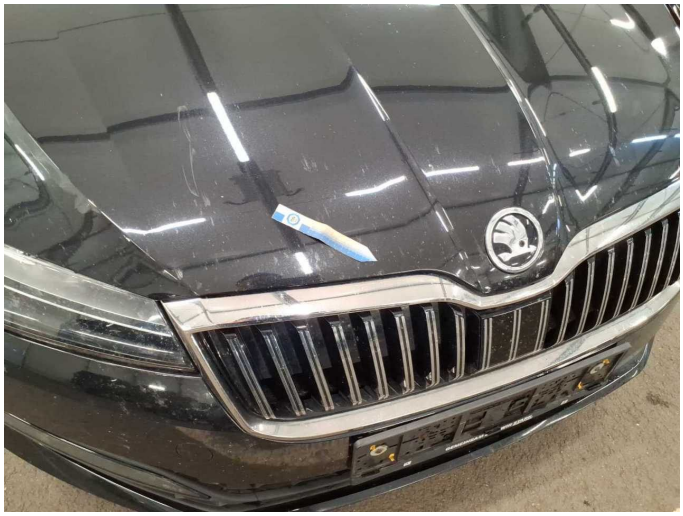
Damage 6: Bonnet: Bonnet (Steinschlag mit Korrrosionsansatz) - Corrosion - Paint

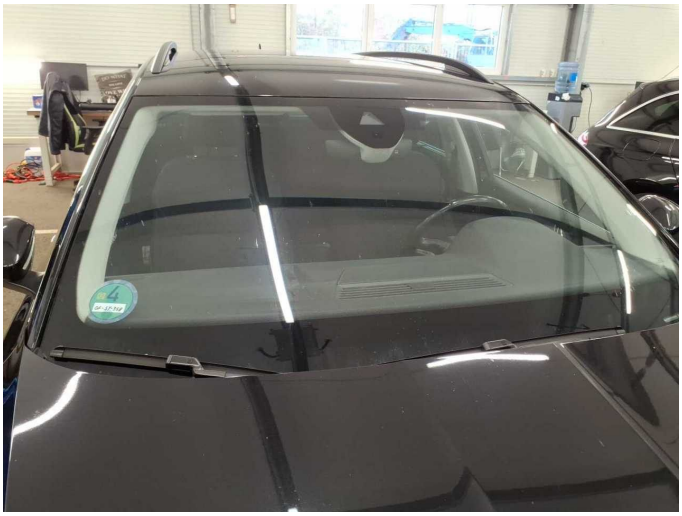
Wear and tear 1: Vehicle glazing: Windscreen - Stone chips - No deduction

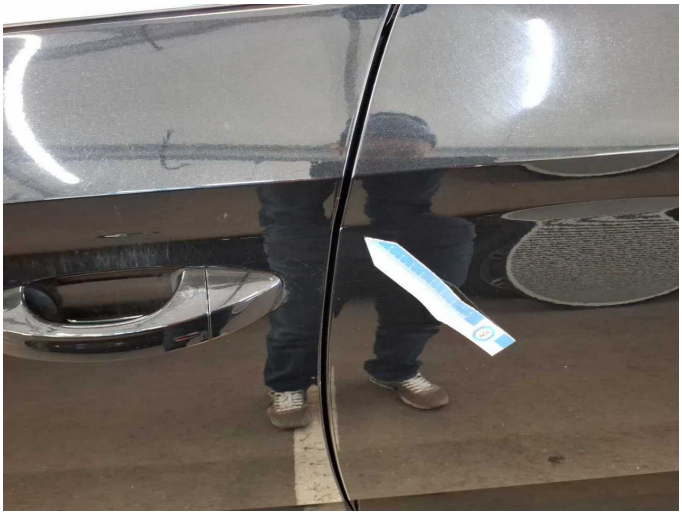
Wear and tear 2: Door - rear right side: Door - Scratch(es) - No deduction
