MACADAM

BMW X2

Vehicle information

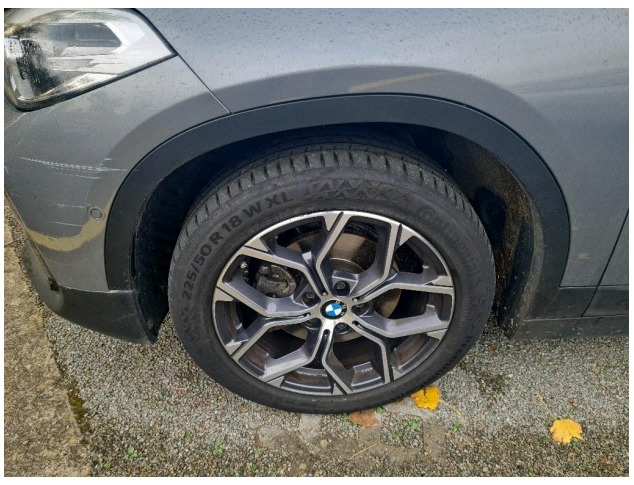
Polished front right alloy wheel
with scratches on
the left - Repair and paint (complete)

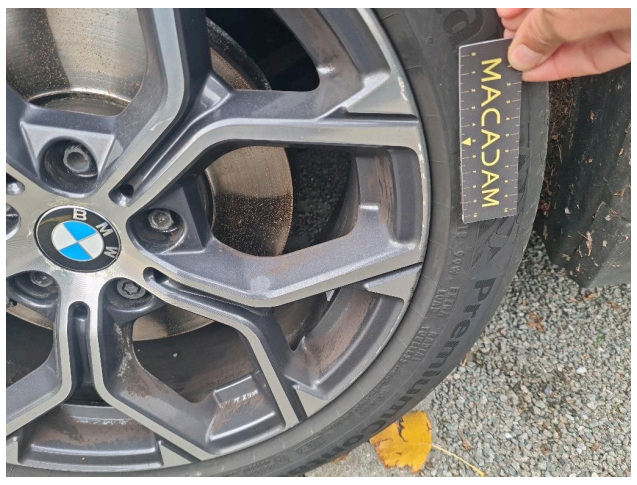
Polished front left alloy wheel
with scratches
on the left - Repair and paint (complete
)
