Expertise

Protocol number: 48452413
Order No. / Reference: 27140352
Inspection date: 15 Oct 2026

Manufacturer: Skoda	Model: Karoq 2.0 TDI SCR 4x4 DSG Style
VIN: TMBLJ7NU1P5067721

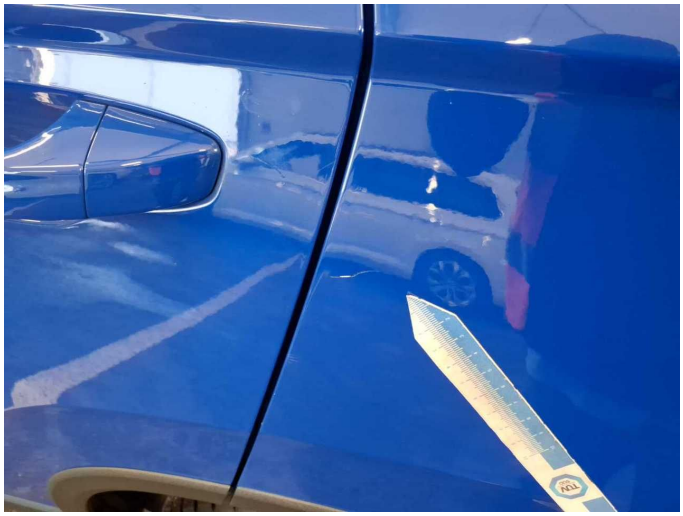
No.	Component group	Description
1	Side panel - rear left side	Side panel - Scratched - Paint
2	Front bumper	Front bumper - Scratch(es) - Paint

Damage 1: Side panel - rear left side: Side panel - Scratched - Paint

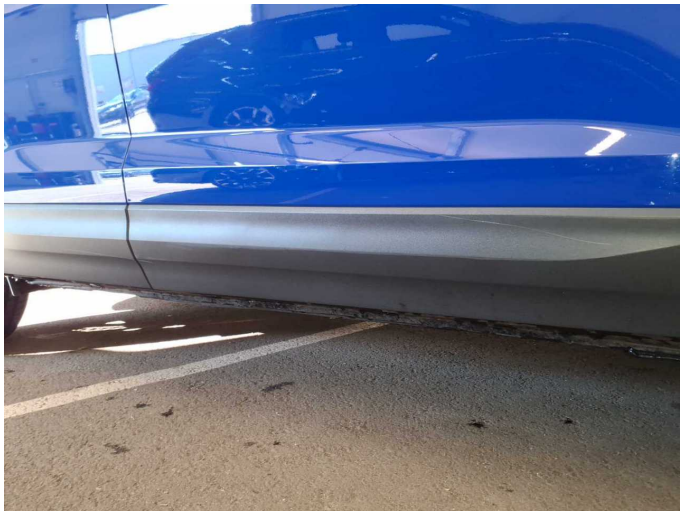
No.	Accident
1	Side right

Accident 1: Side right
