Expertise

Protocol number: 48472002
Order No. / Reference: 27211011-1
Inspection date: 27 Oct 2026

Manufacturer: Opel	Model: Astra Sports Tourer 1.5 D Automatik Ultimate
VIN: VXKFCYHZ5R1024852

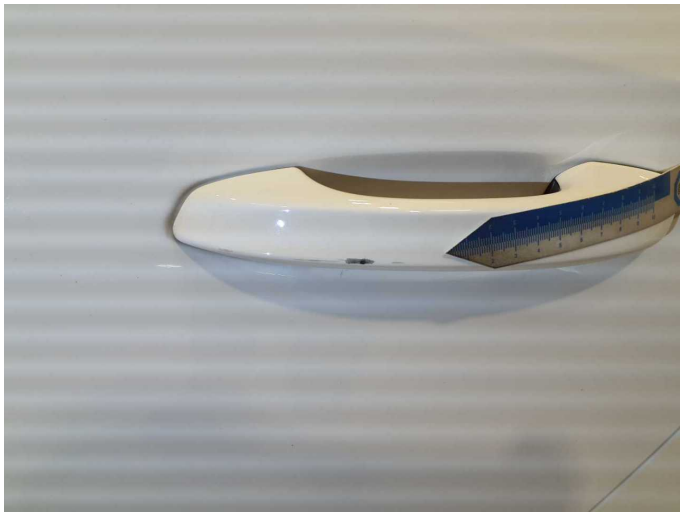
Damage 1: Door - rear left side: Door handle - outside - Scratch(es) - Smart repair

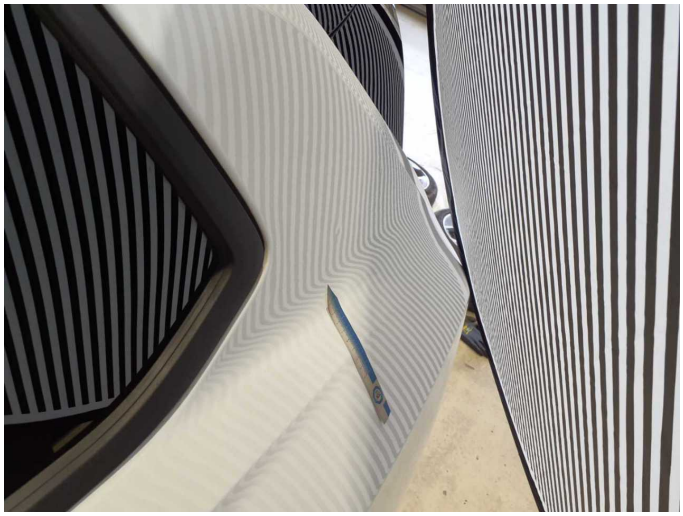
Damage 4: Side panel - rear left side: Side panel - Dent / paintcoat damage - Smart repair

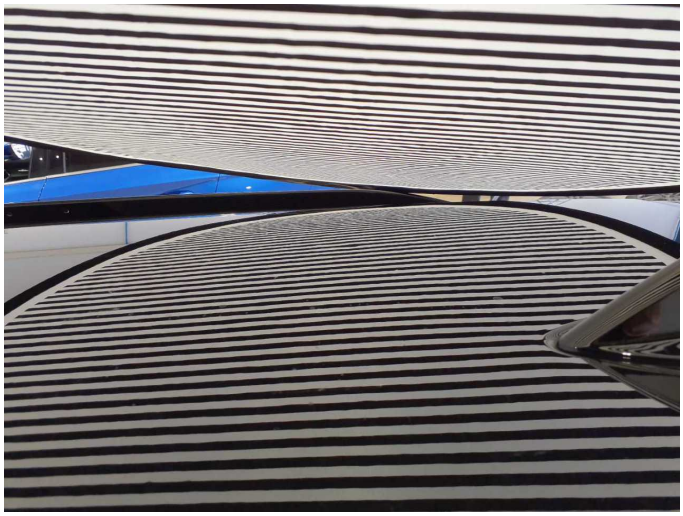
Damage 9: Roof: Roof - Scratch(es) - Paint

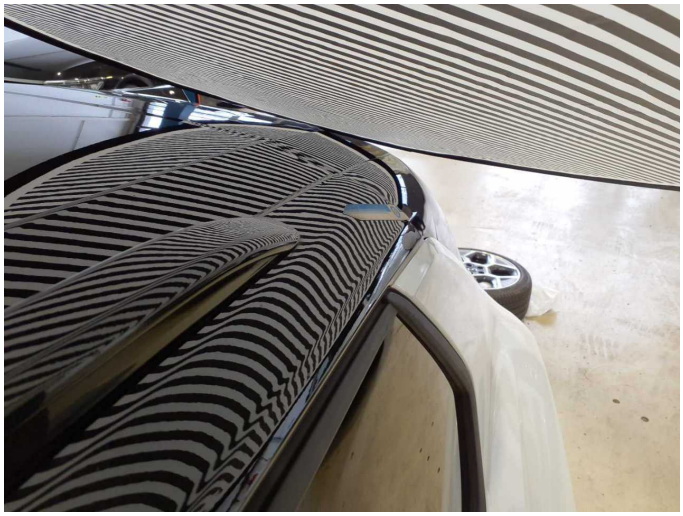
Wear and tear 5: Roof: Roof rail - left side - dent(s) - No deduction
