Expertise

Protocol number: 48430516
Order No. / Reference: 27198638
Inspection date: 29 Oct 2026

Manufacturer: Seat	Model: Arona 1.0 TSI OPF Xperience
VIN: VSSZZZKJZNR047266

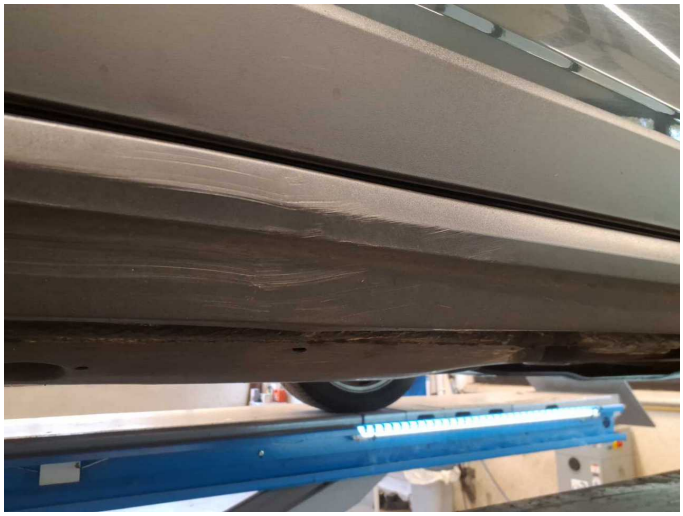
Damage 2: Sill - right side: Trim - Scratched - Replace

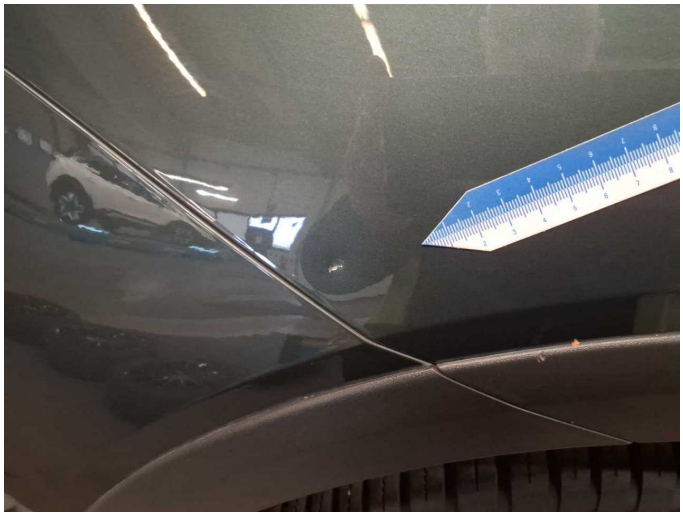
Damage 6: Side panel - rear right side: Side panel - Dent / paintcoat damage - Paint

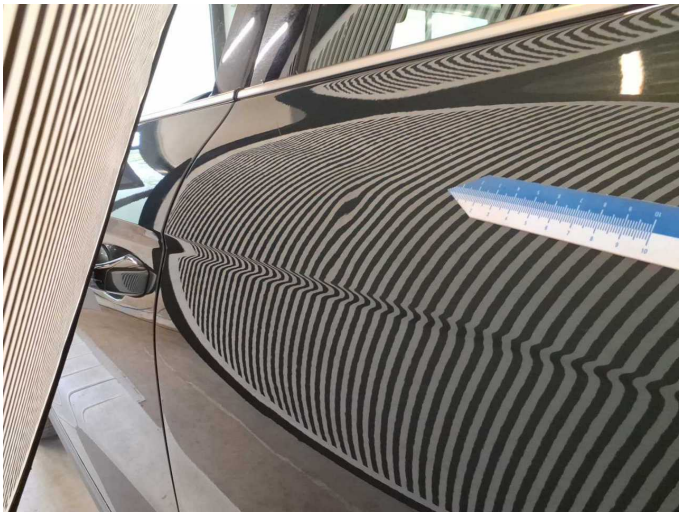
Damage 7: Door - rear left side: Door - Dent / paintcoat damage - Repair and paint

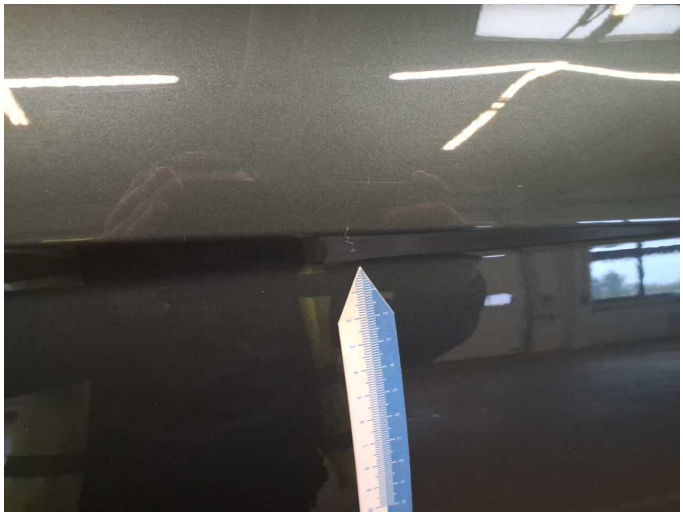
Damage 7: Door - rear left side: Door - Dent / paintcoat damage - Repair and paint
