TÜV SÜD Auto Partner GmbH
Wiesenring 2
04159 Leipzig

Expertise

Protocol number: 48054749
Order No. / Reference: 27080492
Inspection date: 12 Oct 2026

Manufacturer: Skoda	Model: Kodiaq 2.0 TDI 4x4 DSG Sportline
VIN: TMBLN7NS2P8059645

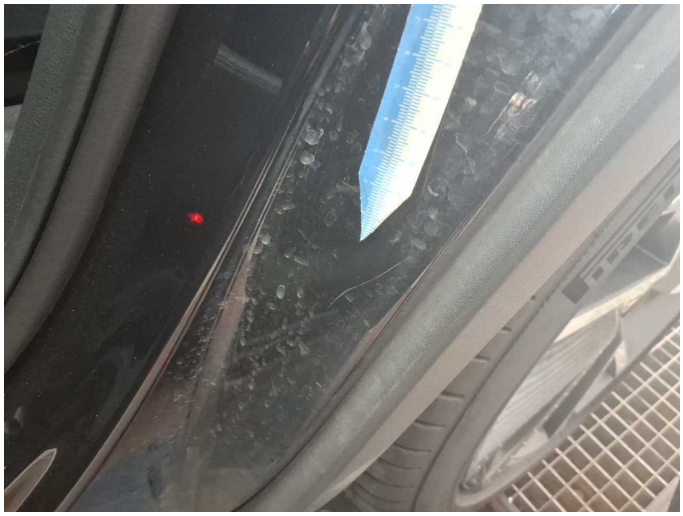
Damage 5: Side panel - rear left side: Sill - Scratch(es) - Smart repair
