Expertise

Protocol number:	44366956
Order number / reference:	25805062
Inspection date:	12 Mar 2026

Manufacturer: Volkswagen	Model: Tiguan 2.0 TDI SCR DSG Life
VIN: WVGZZZ5NZNW046244

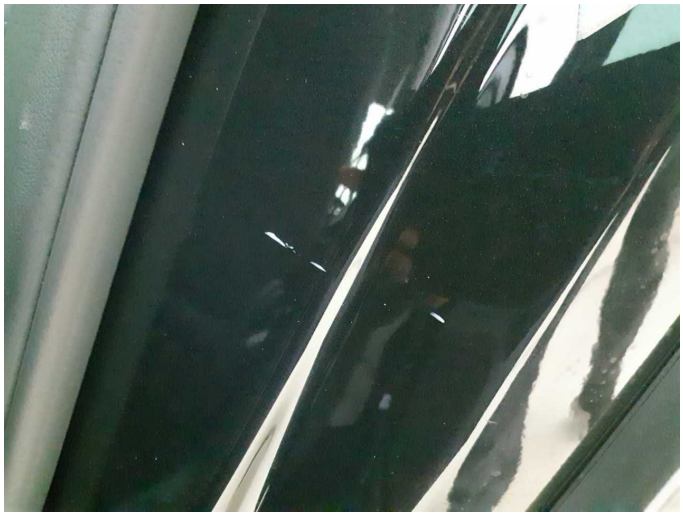
Damage 4: Door - front right side: Door - Scratch(es) - Smart repair
