Expertise

Protocol number: 48108104
Order No. / Reference: 26976231
Inspection date: 14 Oct 2026

Manufacturer: Opel	Model: Mokka 1.2 DI Turbo Automatik Elegance
VIN: VXKUSHNSSMW097104

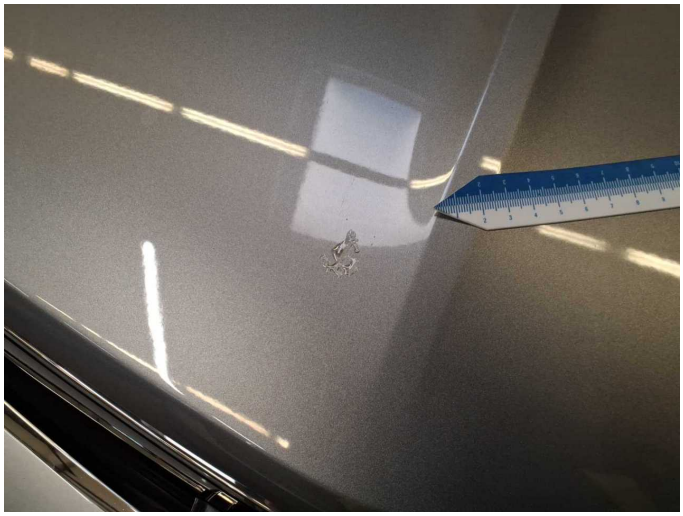
Damage 3: Front bumper: Front bumper (Harzflecke, reinigen, aufbereiten) - Paint defect - Smart repair

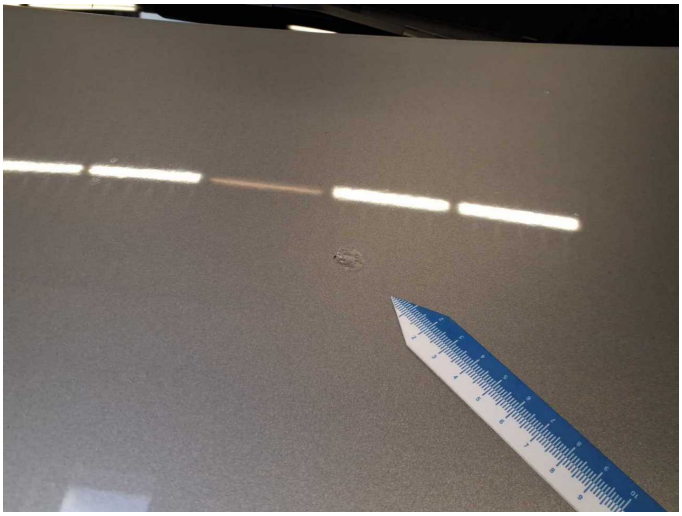
Damage 4: Bonnet: Bonnet (Harzflecken, reinigen, aufbereiten) - Paint defect - Smart repair
