Expertise

Protocol number: 48444730
Order No. / Reference: 27217720
Inspection date: 30 Oct 2026

Manufacturer: Opel	Model: Astra 1.5 D Automatik GS
VIN: VXKFBYHZ7R1062117

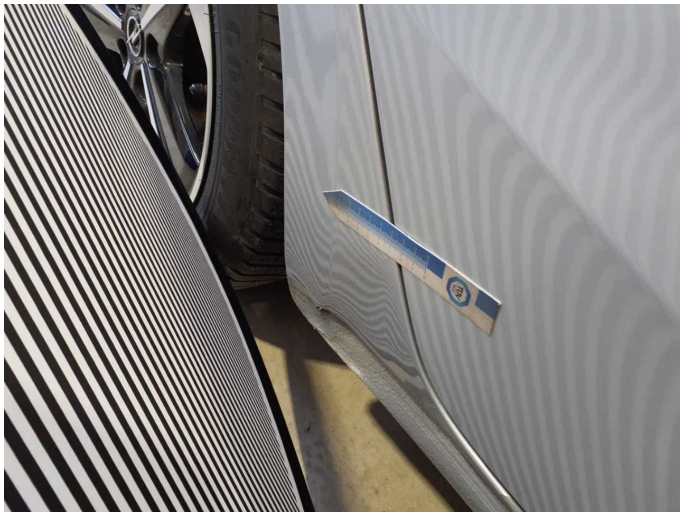
No.	Component group	Description
1	Side panel - rear right side	Side panel - dent(s) - Smart repair
2	Wheel / tyres	Alloy rim - front right side - Scratch(es) - Loss in value
3	Engine	Engine cover - Damage caused by marten / rodent - Replace
4	Rear bumper	Rear bumper - Broken / torn - Replace
5	Sill - right side	Sill - Deformed - Replace

Damage 1: Side panel - rear right side: Side panel - dent(s) - Smart repair
