MERCEDES-BENZ A-CLASS (W177)

Vehicle information

Summary of damages

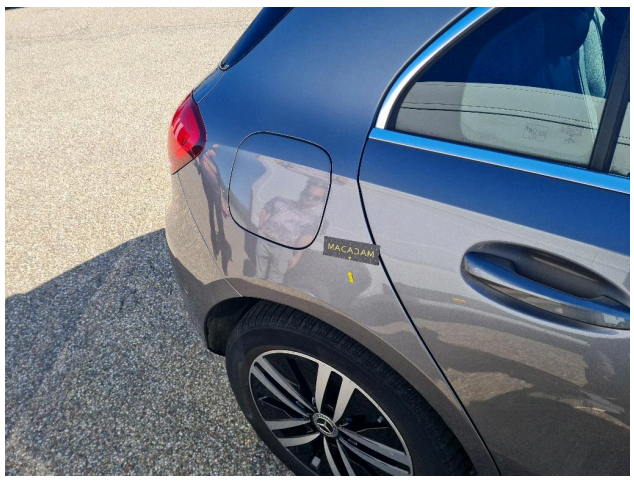
Bodywork

Damaged -

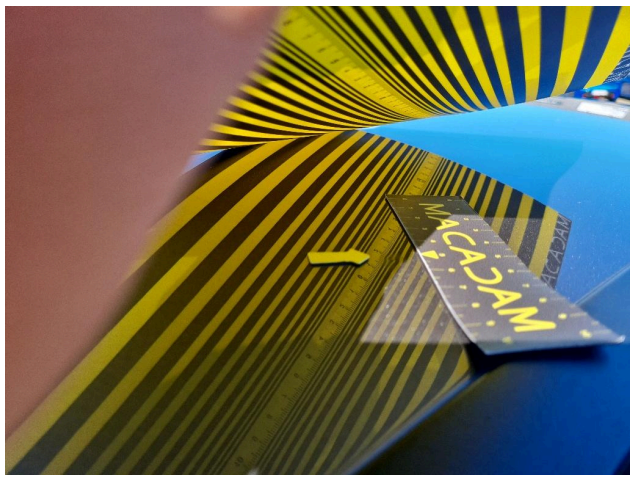
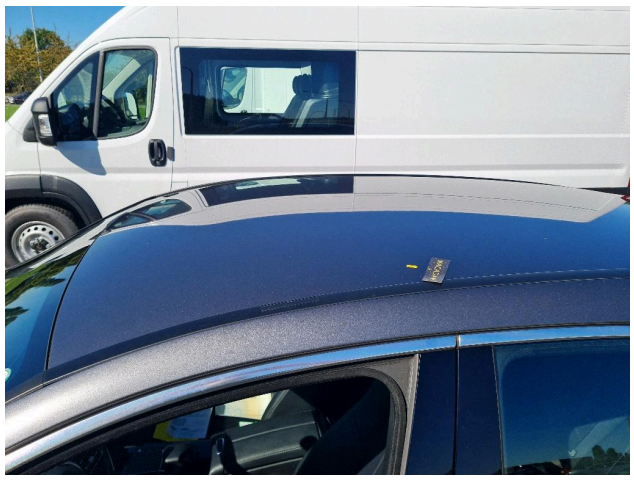
Acceptable.

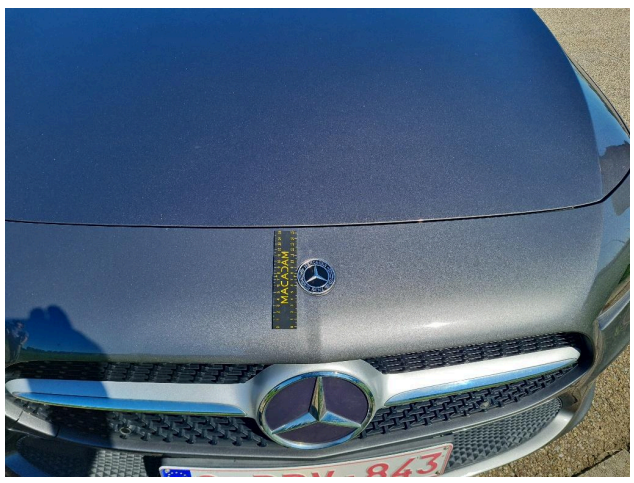
Polished front right alloy wheel
with scratches on
the left - Repair and paint (complete)

AV Forced E **Brand Monogram**
- Replace
Before

Front bumper,
scratch(es),
paint
front

Left-hand door.
Dent(s) and scratch(es) .
Paint.
