Expertise

Protocol number: 48309499
Order No. / Reference: 27167028
Inspection date: 22 Oct 2026

Manufacturer: Skoda	Model: Kodiaq 2.0 TDI DSG Style
VIN: TMBJJ7NS8P8054534

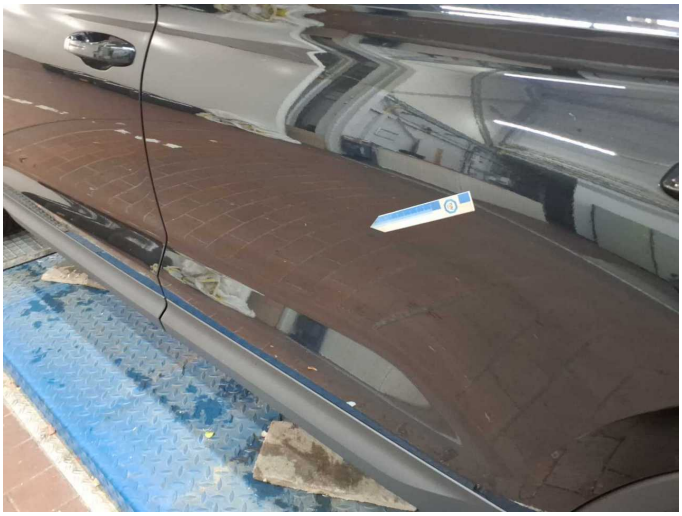
No.	Component group	Description
1	Door - rear left side	Door - dent(s) - Smart repair

Damage 1: Door - rear left side: Door - dent(s) - Smart repair

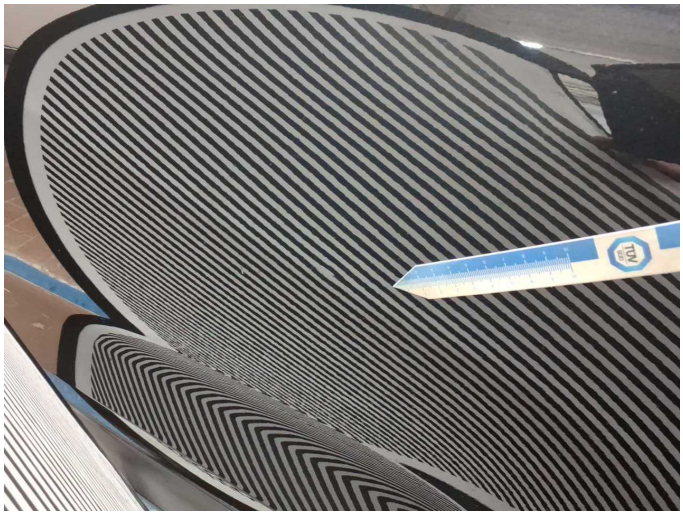
Damage 1: Door - rear left side: Door - dent(s) - Smart repair
