Expertise

Protocol number: 48556525
Order No. / Reference: 27284444
Inspection date: 6 Nov 2026

Manufacturer: Volkswagen	Model: Transporter T6.1 Lang
VIN: WV1ZZZ7HZMH003313

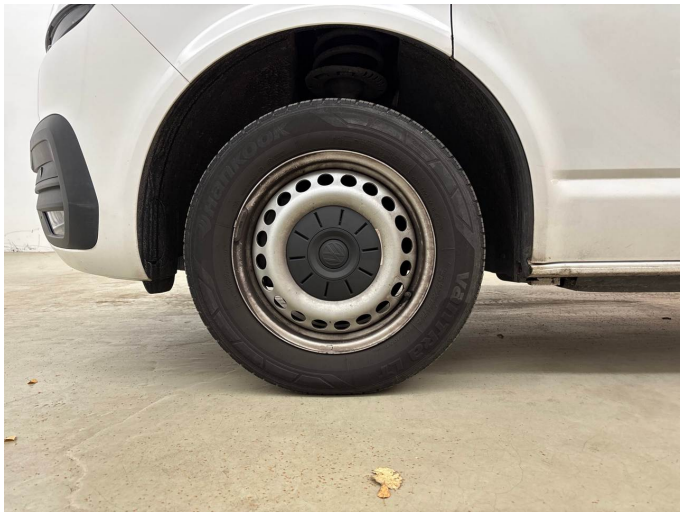
Figure 12: Mounted tyres

#	Tyre size	Type of tyre	Manufacturer	Tread depth
1)	205/65 R16 107T	Summer tyres on Light alloy	Hankook	5mm / 5mm
2)	205/65 R16 107T	Summer tyres on Light alloy	Hankook	6mm / 6mm

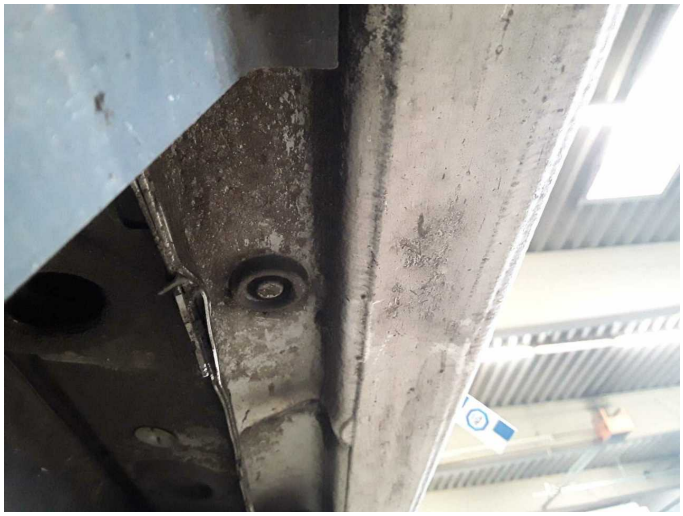
Damage 12: Sill - left side: Sill - Dent / paintcoat damage - Smart repair
