Expertise

Protocol number: 48187803
Order No. / Reference: 26863547
Inspection date: 15 Oct 2026

Manufacturer: Skoda	Model: Kodiaq 2.0 TDI DSG Ambition
VIN: TMBJJ7NS0P8052082

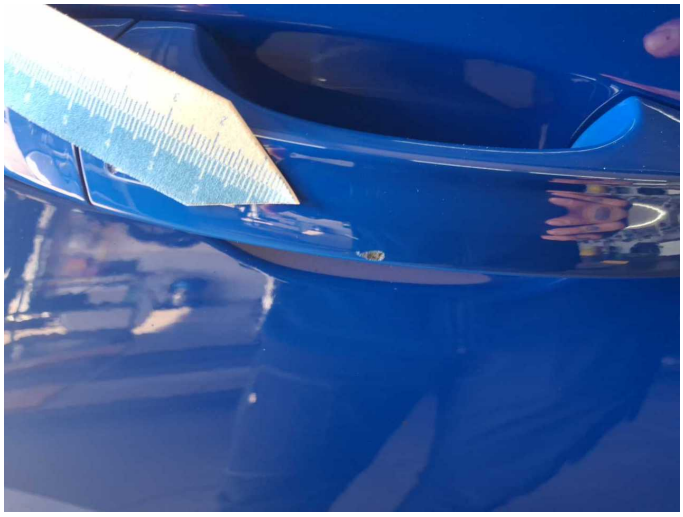
Damage 1: Door - rear right side: Door handle - outside - Scratch(es) - Smart repair

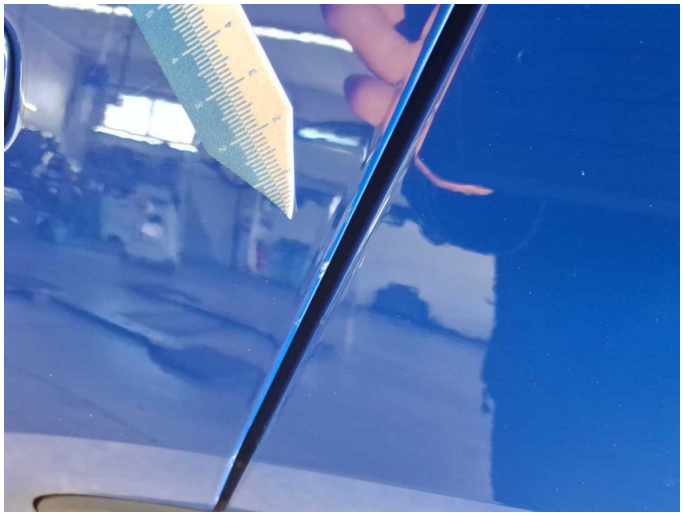
Damage 2: Door - rear left side: Door edge - Scratch(es) - Smart repair

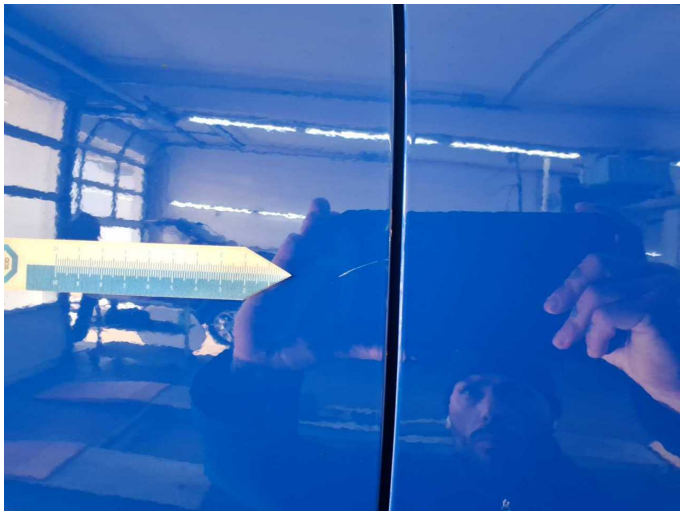
Damage 3: Door - rear right side: Door - Scratch(es) - Smart repair

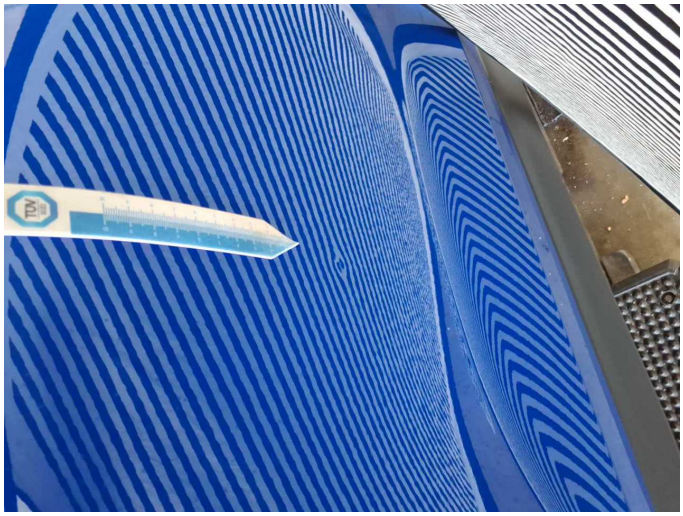
Wear and tear 4: Side panel - rear left side: Side panel - dent(s) - No deduction
