Expertise

Protocol number: 48372943
Order No. / Reference: 27174971
Inspection date: 26 Oct 2026

Manufacturer: Mercedes-Benz	Model: Vito 116 CDI Extralang HA BASE
VIN: W1V44760514103714

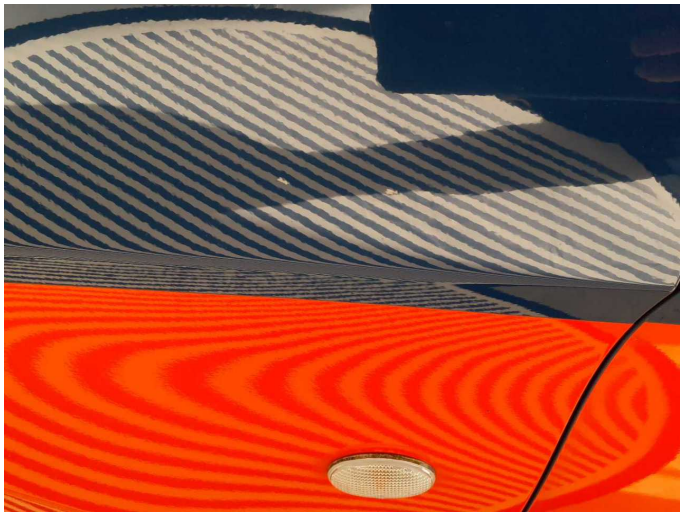
Damage 9: Mudguard - left side: Mudguard - left side - Deformed - Replace

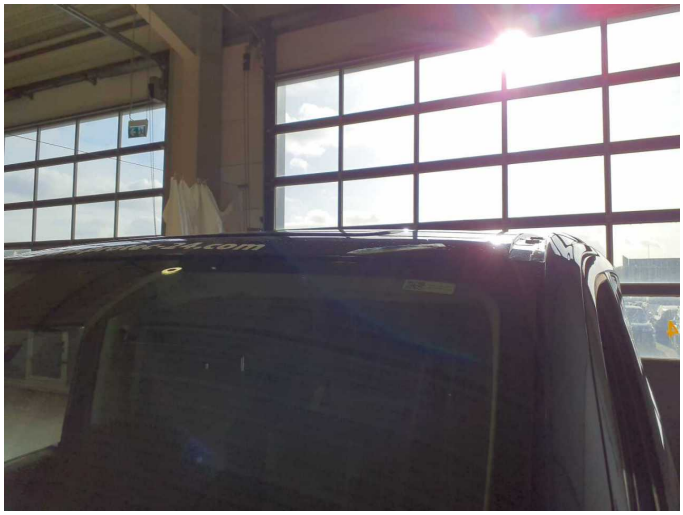
Damage 11: Boot lid / rear door: Boot lid - Corrosion - Repair and paint

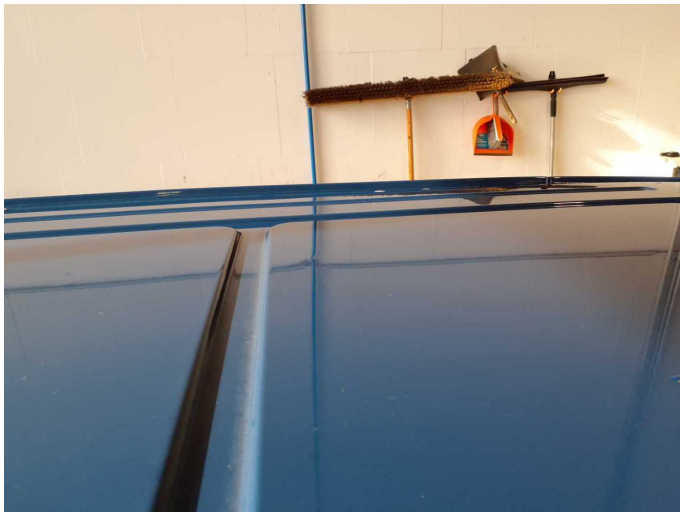
Damage 12: Roof: Roof - Corrosion - Repair and paint

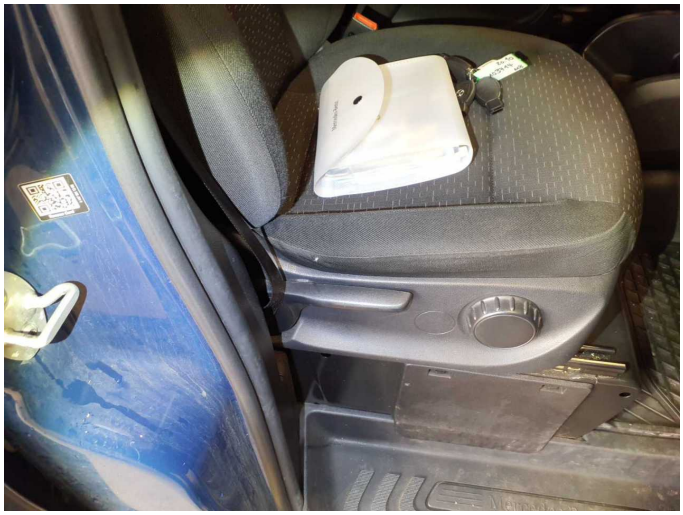
Wear and tear 2: Door - front right side: Door - Scratch(es) - No deduction
