TÜV SÜD Auto Partner GmbH
Wiesenring 2
04159 Leipzig

Expertise

Protocol number: 48508888
Order No. / Reference: 27198956
Inspection date: 30 Oct 2026

Manufacturer: Ford	Model: Transit Connect 200 L1 S&S Trend
VIN: WF0RXXWPGRMD26666

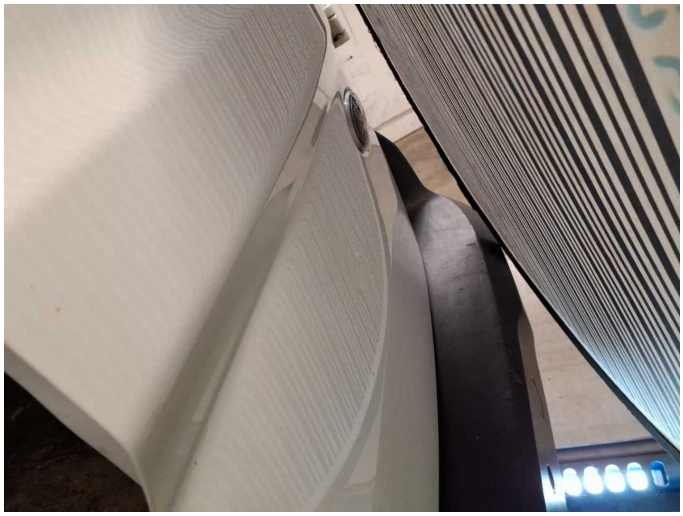
Damage 9: Boot lid / rear door: Rear door - right side - Dent / paintcoat damage - Repair and paint

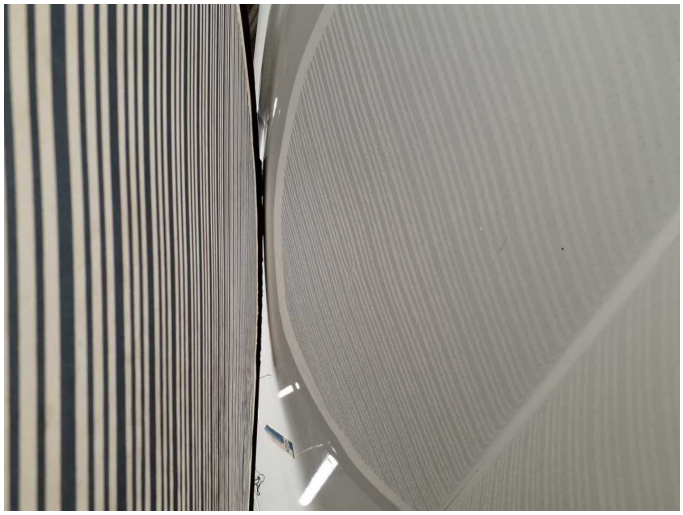
Damage 10: Side panel - rear left side: Side panel - Dent / paintcoat damage - Repair and paint
