Expertise

Protocol number: 48216215
Order No. / Reference: 27114819
Inspection date: 24 Sept 2026

Manufacturer: Skoda	Model: Octavia Combi 2.0 TDI DSG RS
VIN: TMBJK8NX6RY041430

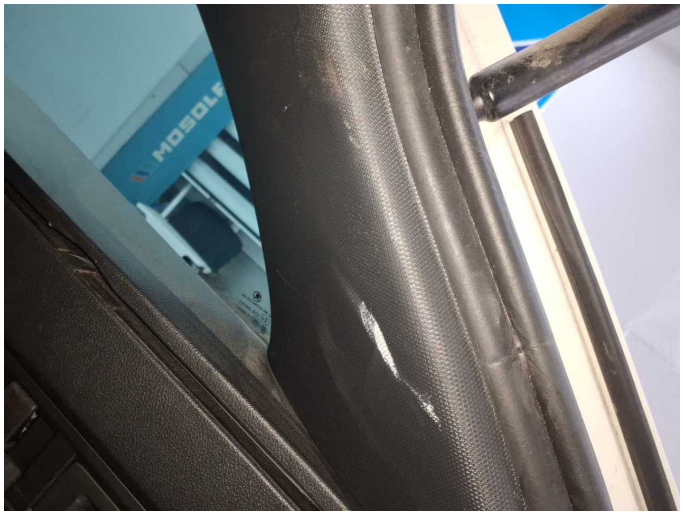
Damage 3: Trim / covers: D-pillar - trim - interior, right side - Soiled - Replace

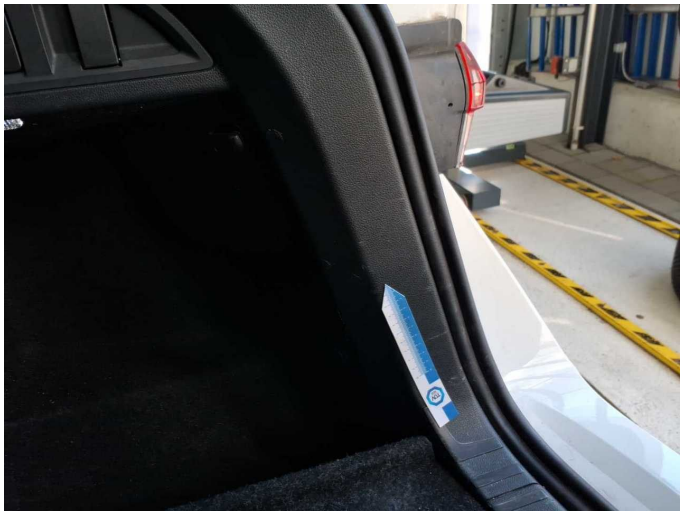
Wear and tear 7: Trim / covers: Boot lining - Scratched - No deduction

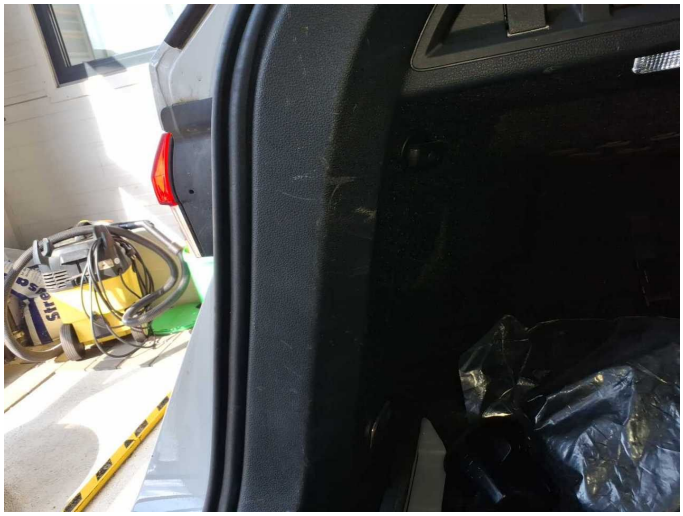
Wear and tear 7: Trim / covers: Boot lining - Scratched - No deduction

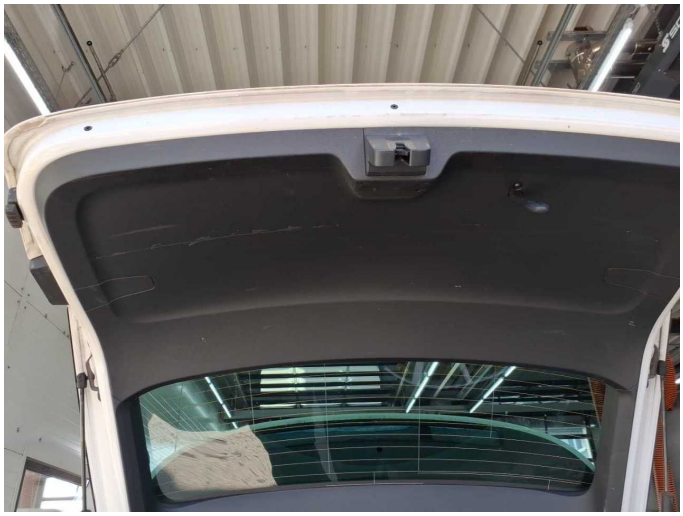
Wear and tear 7: Trim / covers: Boot lining - Scratched - No deduction
