Expertise

Protocol number: 48250508
Order No. / Reference: 27074897
Inspection date: 21 Oct 2026

Manufacturer: Volkswagen	Model: Touran 2.0 TDI SCR DSG Highline
VIN: WVGZZZ1T1RW024260

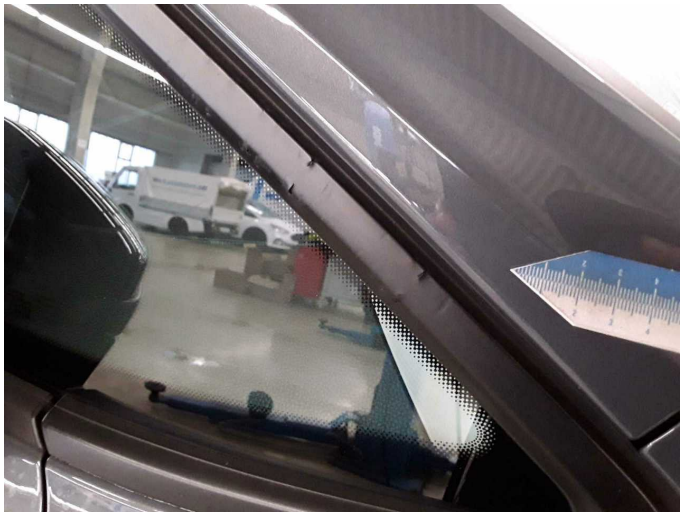
Damage 3: Vehicle glazing: Triangular window - right side (Dichtung) - Broken / torn - Replace

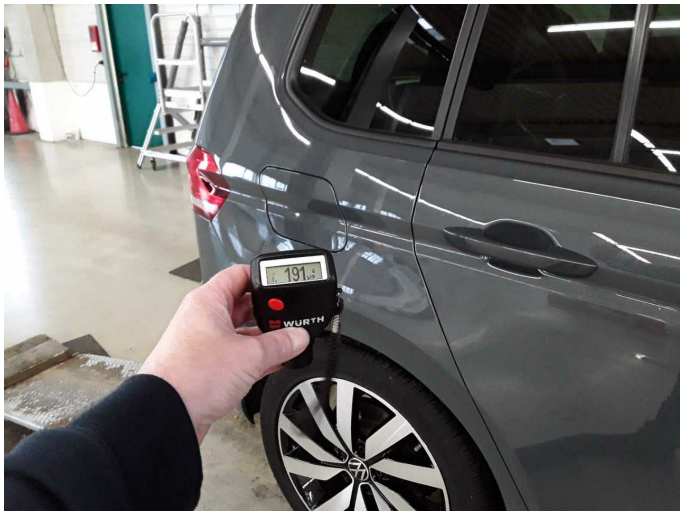
Boot lid / rear door: 519 µm

Side panel - rear right side: 191 µm
