Expertise

Protocol number: 48500400
Order No. / Reference: 27162038
Inspection date: 20 Oct 2026

Manufacturer: Ford	Model: Kuga 1.5 EcoBlue Aut. TITANIUM X
VIN: WF0FXXWPMFNM05304

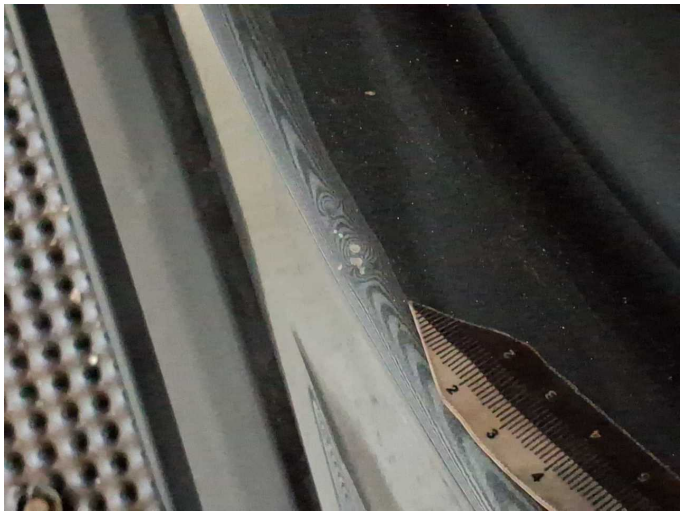
Damage 7: Side panel - rear left side: Sill - Dent / paintcoat damage - Smart repair

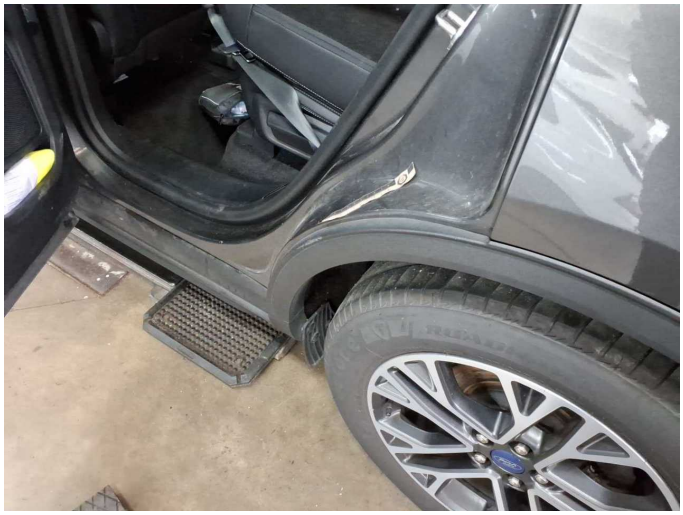
According to available information previous damages were repaired at the vehicle. Traces of repairs, which allow conclusions about the area of repair, were not recognizable during the inspection.

Previous damage 1: Side - left

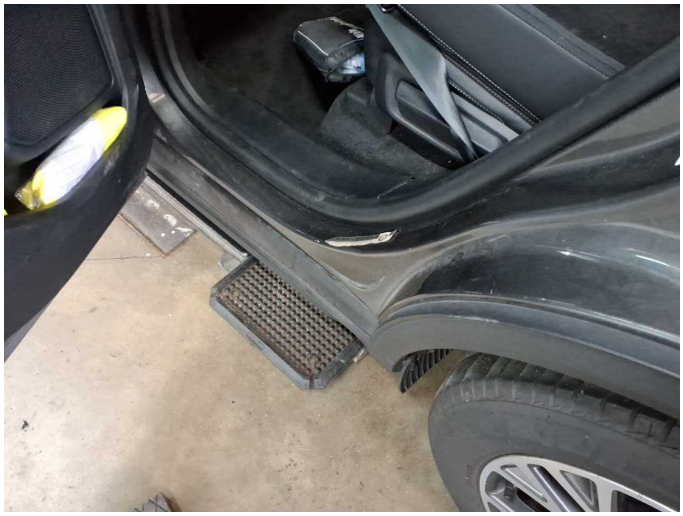
Previous damage 1: Side - left

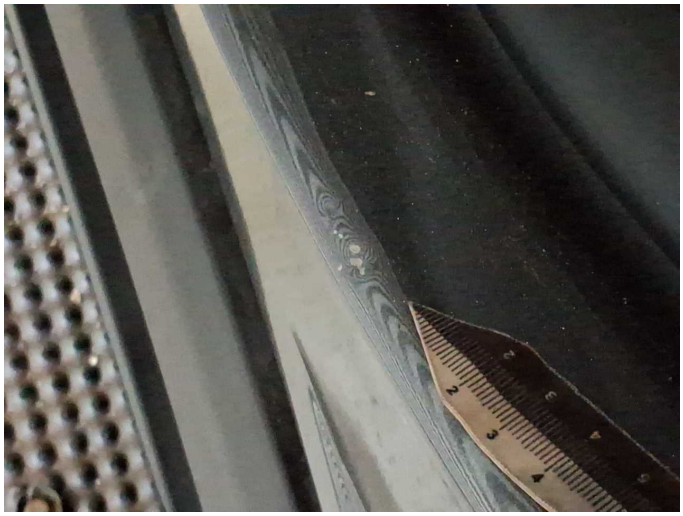
Previous damage 1: Side - left
