Expertise

Protocol number: 48369455
Order No. / Reference: 27230877
Inspection date: 27 Oct 2026

Manufacturer: Ford	Model: Focus Turnier 1.0 EcoBoost Hybrid Aut. ST-LINE X
VIN: WF0PXXGCHPSC41909

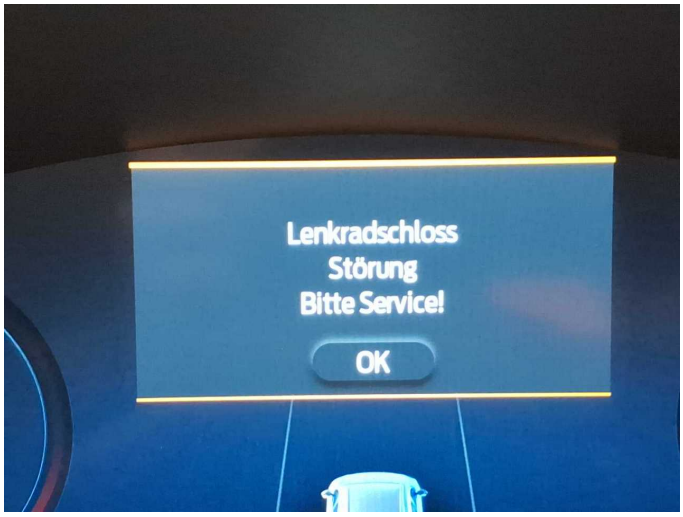
No.	Component group	Description
1	Instrument panel	Indicator light (Lenkradschloss Störung) - on - Perform diagnosis

Damage 1: Instrument panel: Indicator light (Lenkradschloss Störung) - on - Perform diagnosis
