# MERCEDES-BENZ CLA SHOOTING BRAKE

| Model: | **CLA SHOOTING BRAKE** | VIN: | **W1K5M8GB9PN325331** |

## Damages

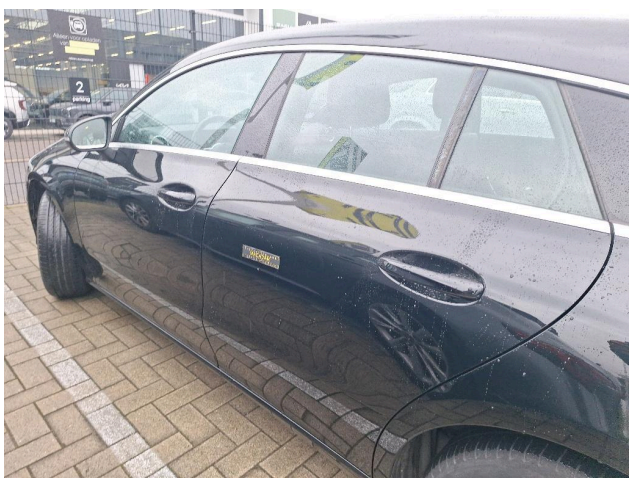
**Bodywork**
Damaged
Acceptable
Roof & others

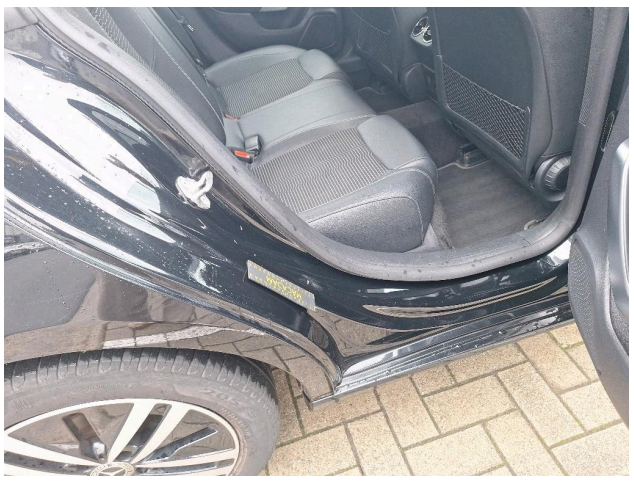
**Step R**

Dent(s) and scratch(es)

Right

Repair and paint (complete)
