ARVAL
BNP PARIBAS GROUP

2CES721

INSPECTION REPORT

End of contract

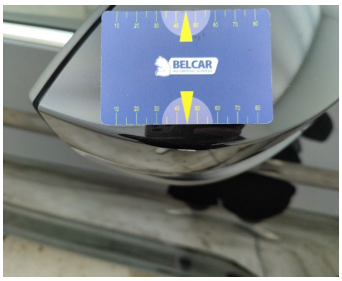
Door Front Right // Painting-scratch

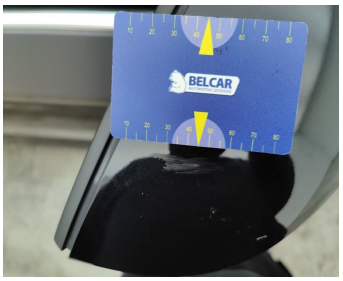
Door Rear Right // Painting-scratch

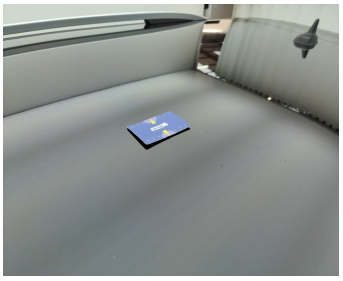
Rocker Panel Left // Smart Repair Medium-dent

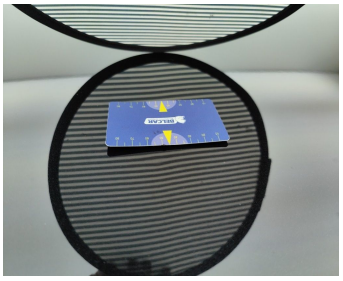
Door Front Left // Repair & Painting-dent
