Expertise

Protocol number: 48517733
Order No. / Reference: 27223394
Inspection date: 5 Nov 2026

Manufacturer: Volkswagen	Model: Tiguan 1.4 eHybrid OPF DSG Life
VIN: WVGZZZ5NZNW406734

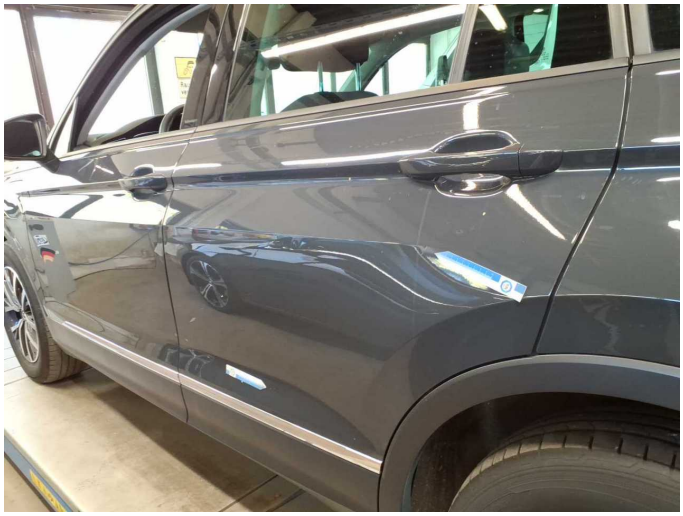
Damage 2: Door - rear right side: Door - dent(s) - Smart repair

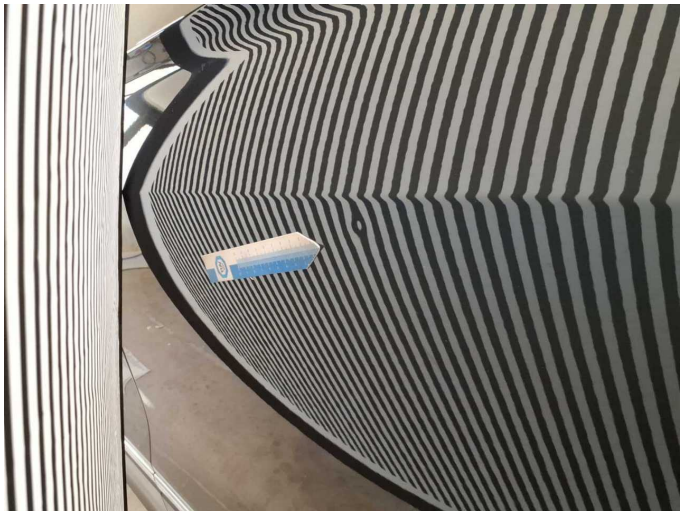
Damage 3: Door - rear left side: Door - Dent / paintcoat damage - Repair and paint

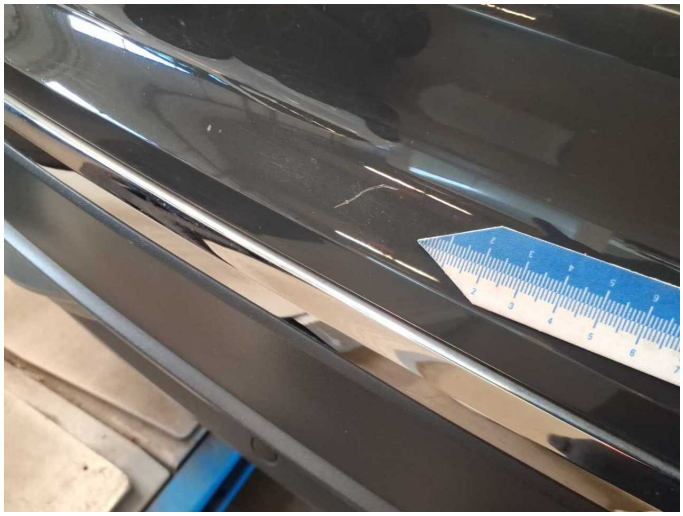
Damage 3: Door - rear left side: Door - Dent / paintcoat damage - Repair and paint

Damage 4: Rear bumper: Rear bumper - Scratch(es) - Paint

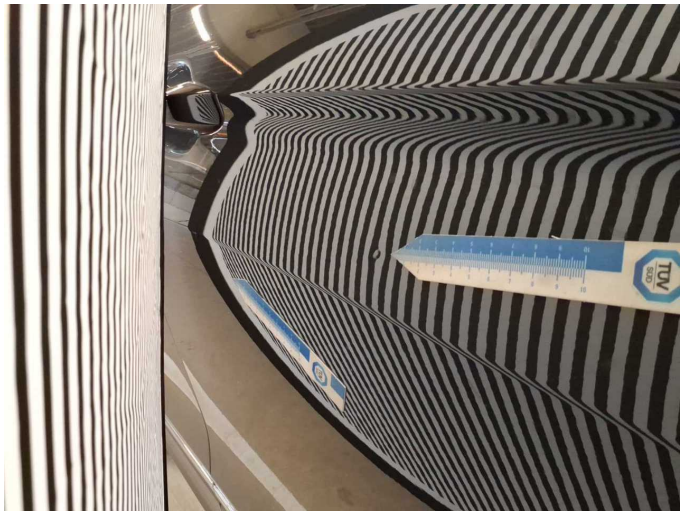
Damage 5: Door - front right side: Door - Dent / paintcoat damage - Repair and paint

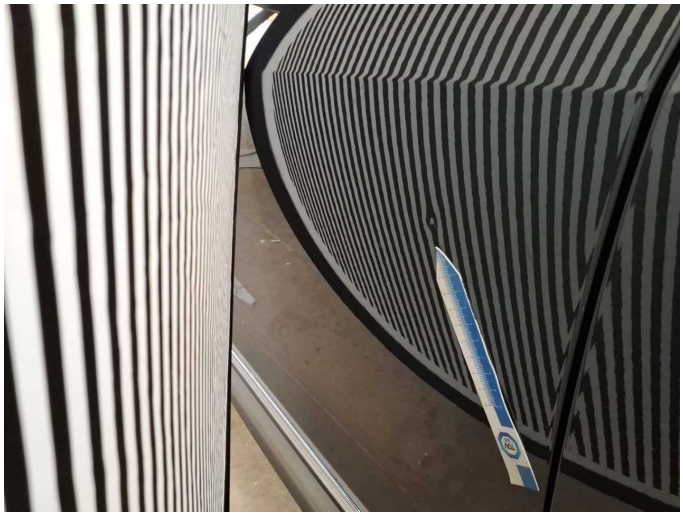
Damage 5: Door - front right side: Door - Dent / paintcoat damage - Repair and paint

Damage 6: Door - front left side: Door - Dent / paintcoat damage - Repair and paint

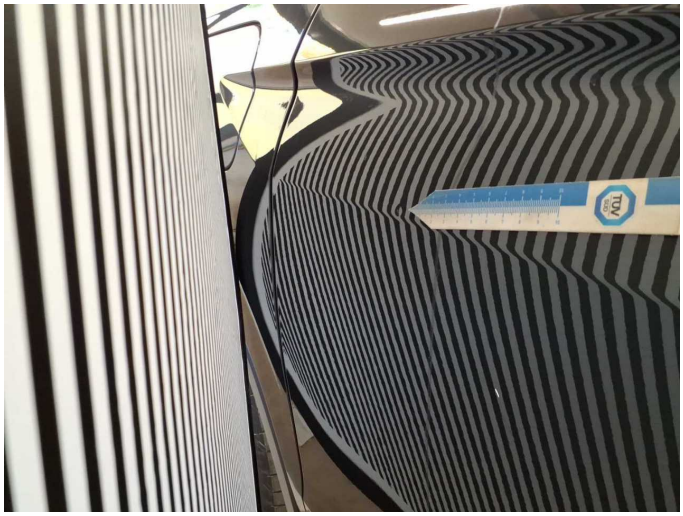
Damage 6: Door - front left side: Door - Dent / paintcoat damage - Repair and paint

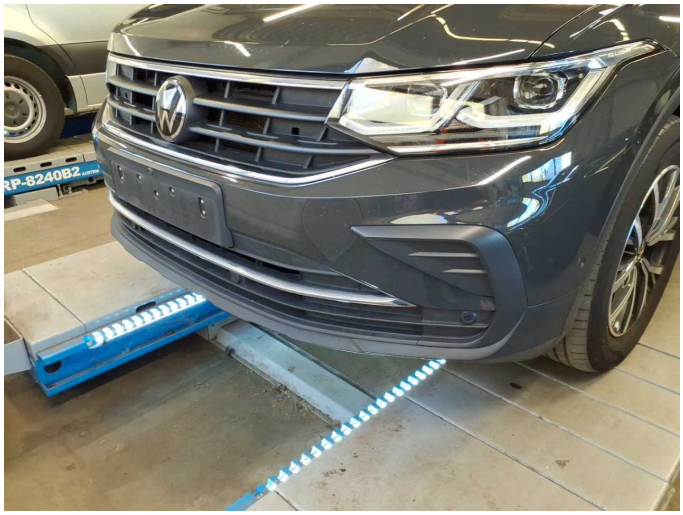
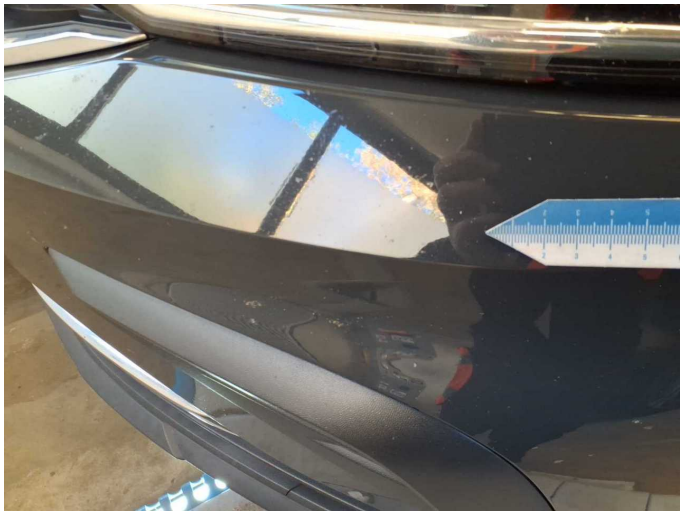
Wear and tear 2: Front bumper: Front bumper - Scratch(es) - No deduction
